Protecting Our Drinking Water through Stream and Sewer Restoration

Southeast New York Stormwater Conference
October 14, 2015

Project Elements

- Evaluation of Potential Stream Restoration Techniques
- Stream Restoration and Erosion Control designs
- Additional hydrologic/hydraulic assessments at four sites (PH-2, PH-6, PH-4, and PH-5)

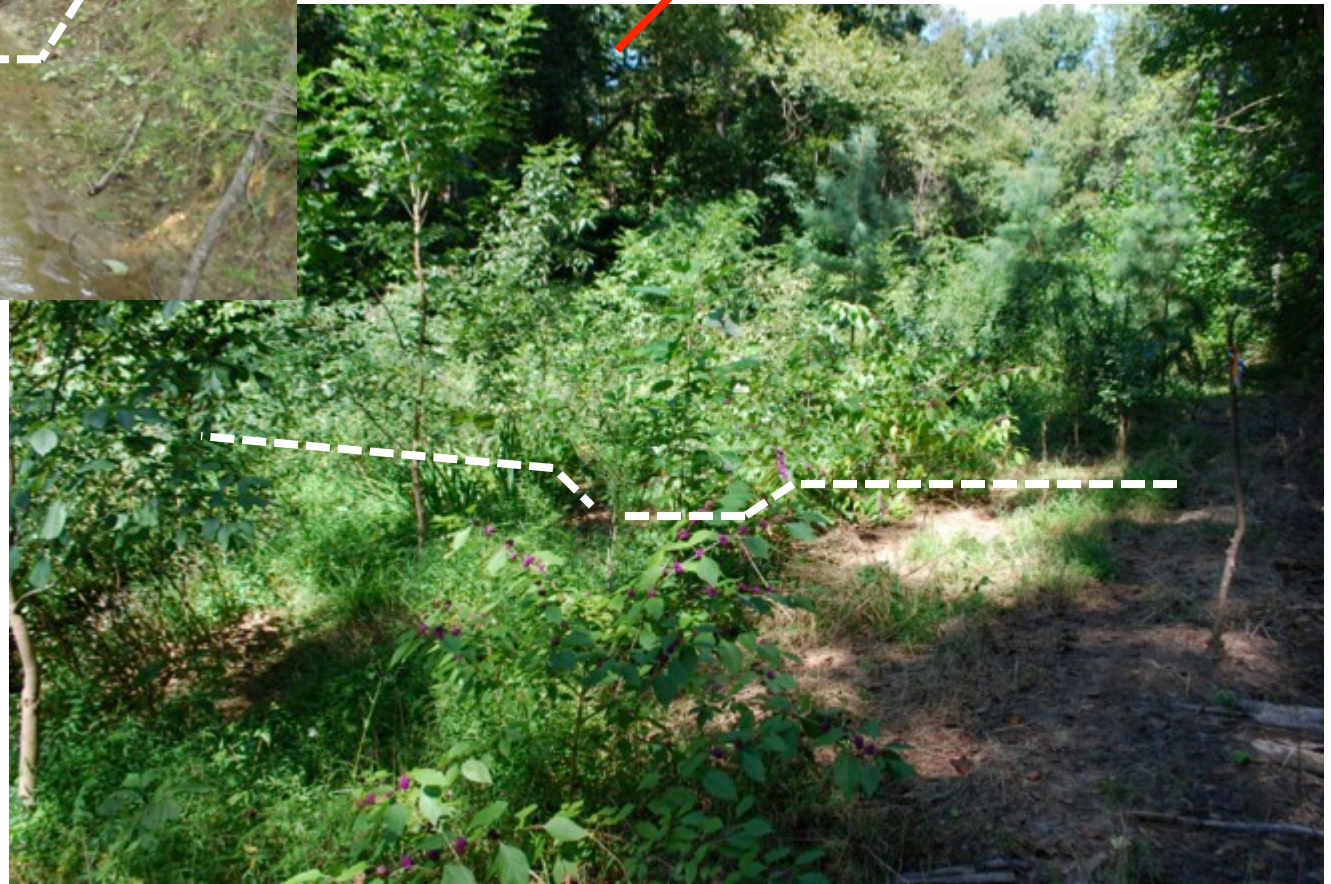
Pre-restoration

Post-restoration

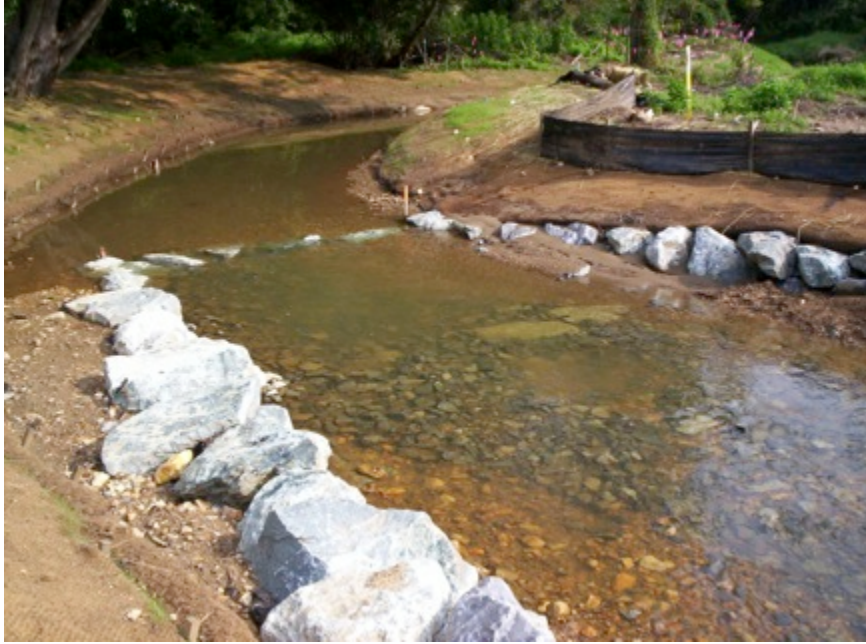
Newly Installed Cross Vane

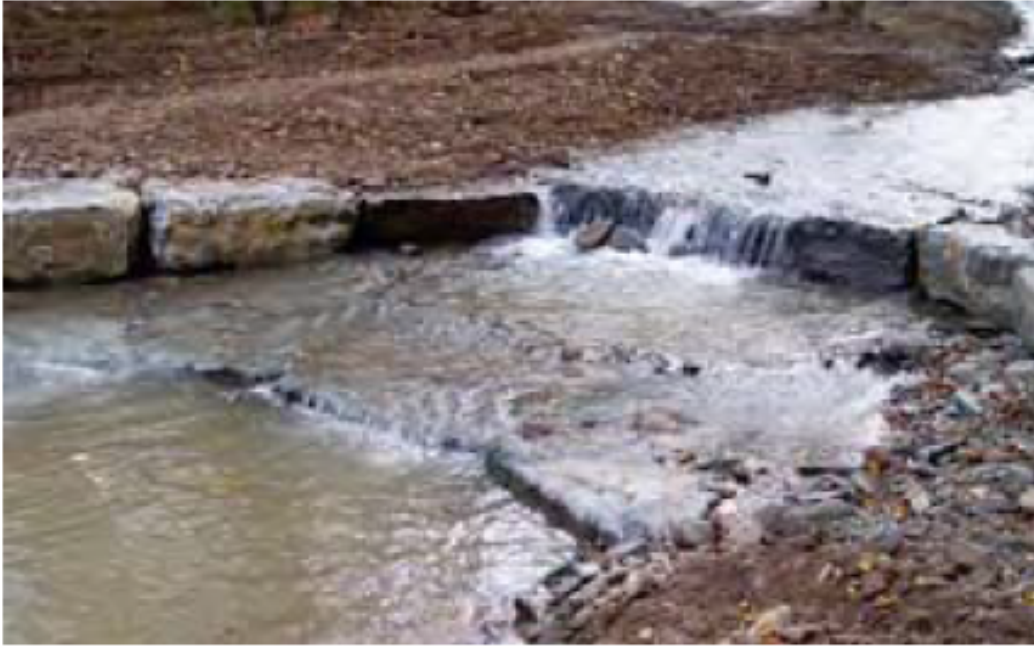
Holliday Brook Emergency Flood Response

- Emergency response prompted by June 2007 flash flood around Pepacton Reservoir
- Constructed in-stream grade control structures:
 - rock-cross vanes
 - double rock-cross vanes three straight
 - rock vane

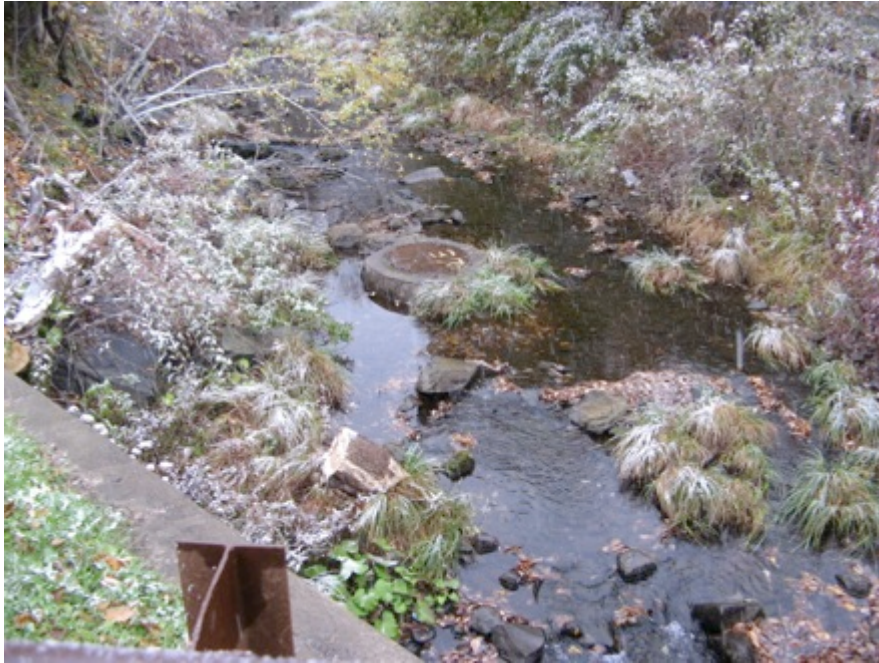
Sewer stream crossing at T-8

CIPP Lining to Minimize Disturbance

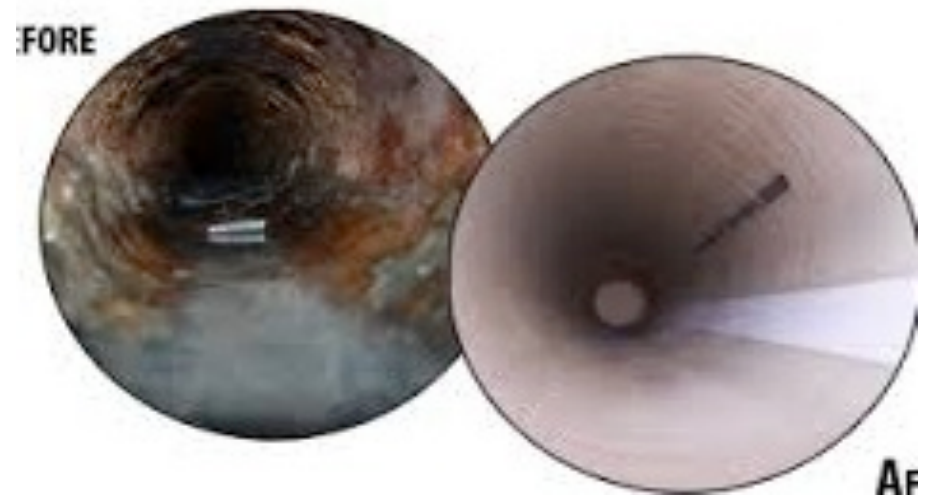
CIPP Lining

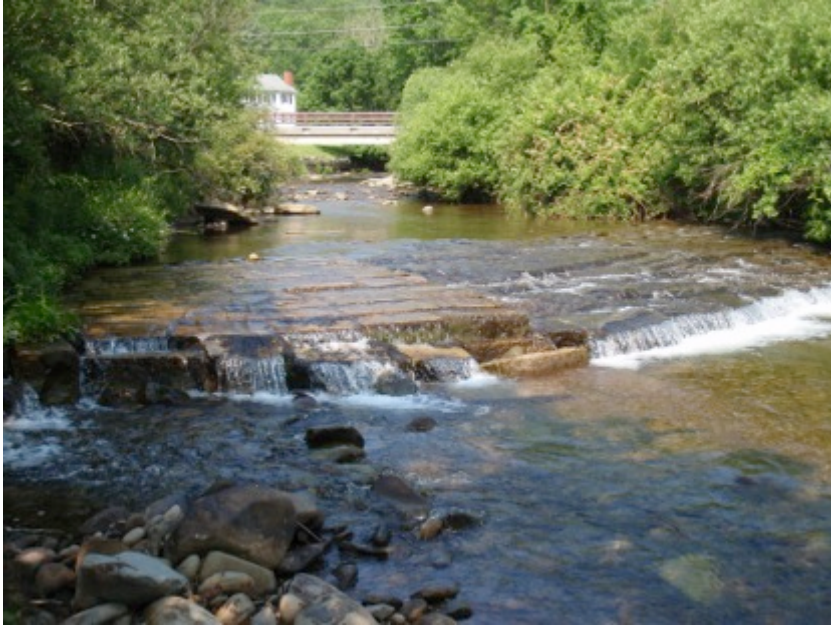
Sewer stream crossing at G-3

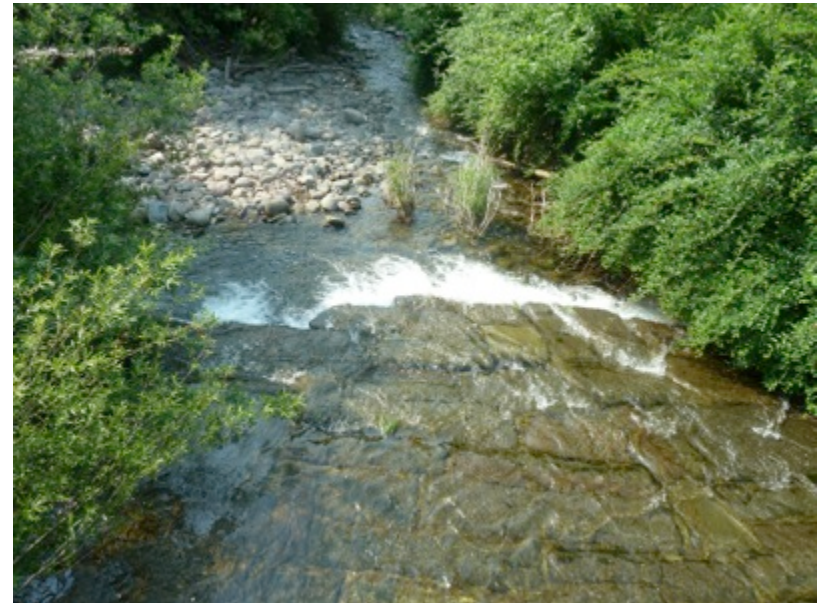
Sewer stream crossing at G-2

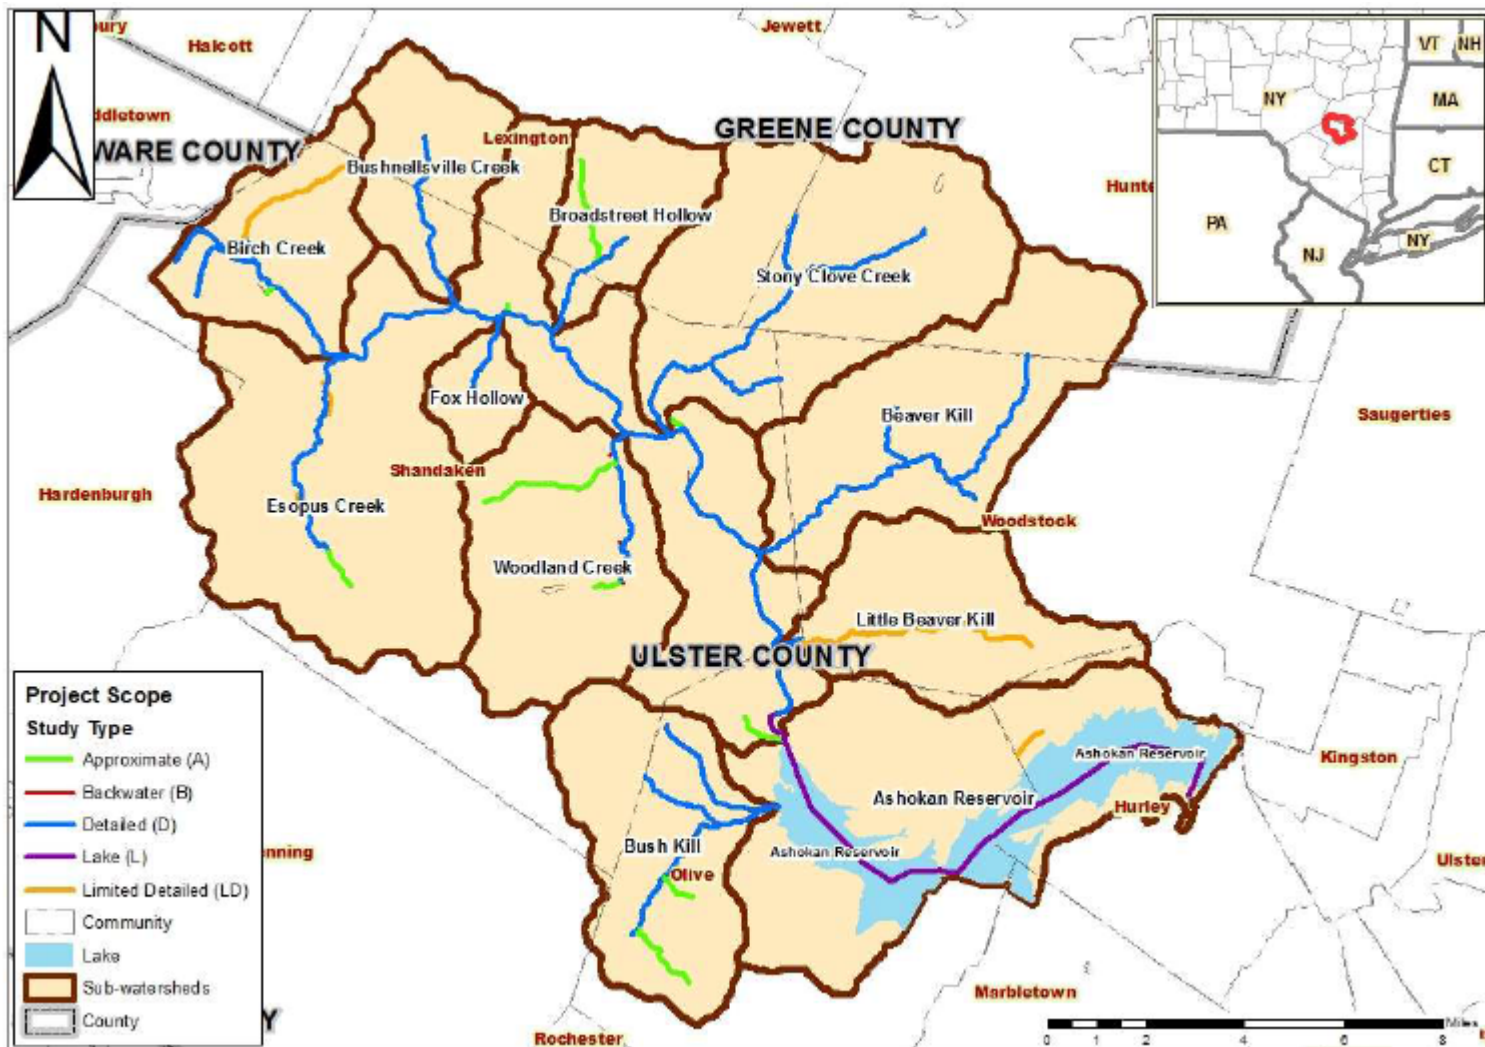
Figure 1: Esopus Watershed boundary with scoped flooding sources and labeled sub-watersheds.

Extracted from FEMA Watershed Hydraulic Study, New York June 2013

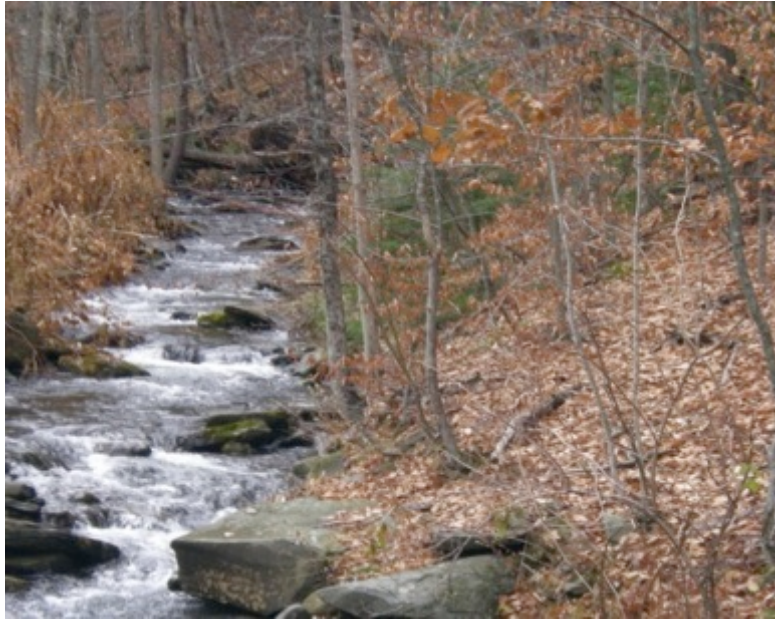
PH-2, view looking upstream from
Bonnie View Ave

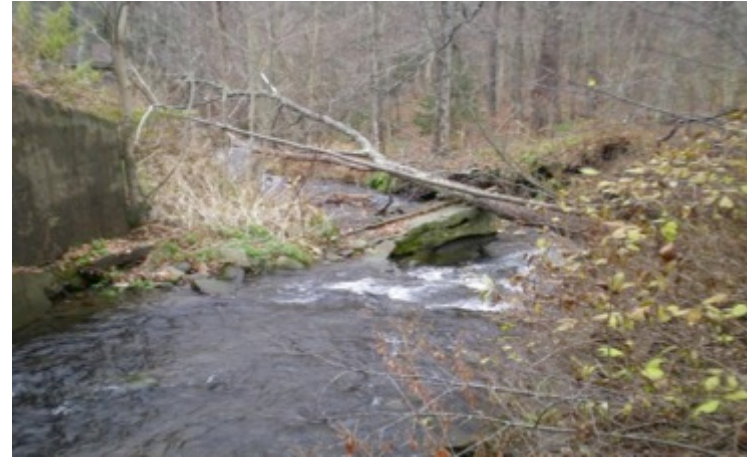
PH-2, view looking downstream from
headwall

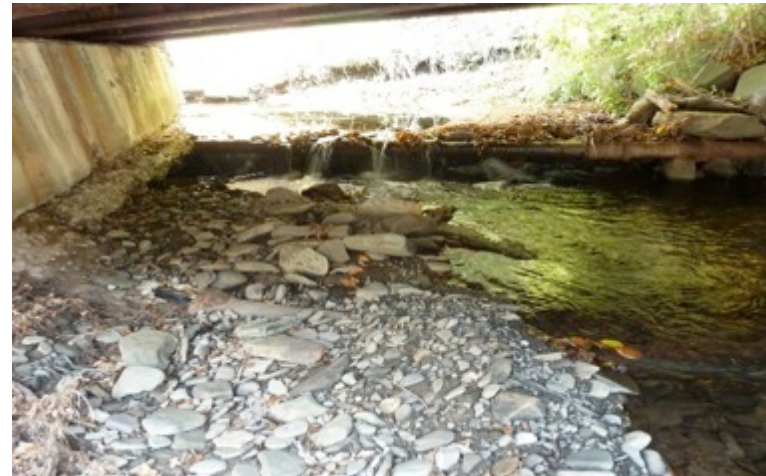
Eroded conditions at Bonnie View Avenue
Bridge

- Detailed Bridge Assessment for PH-2
 - Velocity and shear increases during 100-year storm
 - Velocity under bridge is already elevated, and is likely to remain elevated during proposed condition
- Detailed Culvert Assessment for PH-4
 - Shear stress reduced or experiences a negligible increase
 - Velocity generally remains the same

- Minor floodplain impacts at PH-2, PH-6, and PH-5; considered negligible
- With the exception of PH-6, all water surface increases are confined to channel banks
- Based on results of particle entrainment, only PH-6 is likely to require additional bank stabilization
- The Bonnie View Bridge at the location of PH-2 is currently experiencing erosion and the predicted velocity increases may exacerbate erosion
- Additional stream design at PH-6 and PH-5 to commence shortly

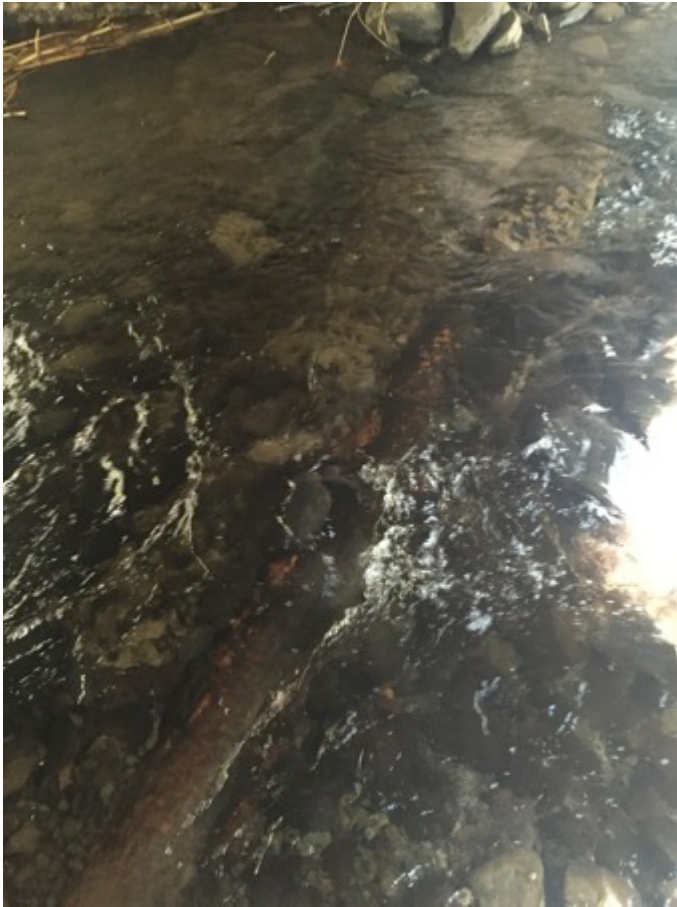
PH-2 Existing Pipe and Concrete Encasement

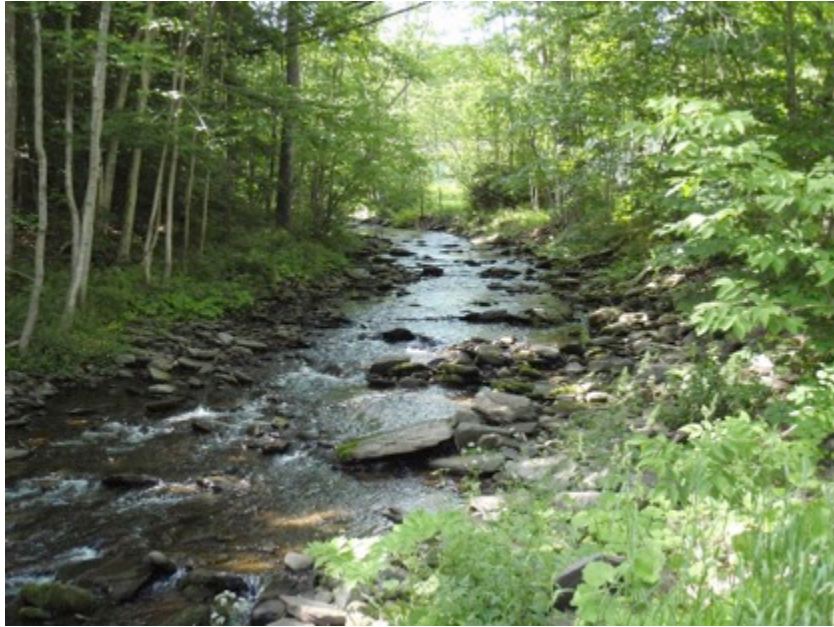
PH-4, view looking upstream from sewer crossing

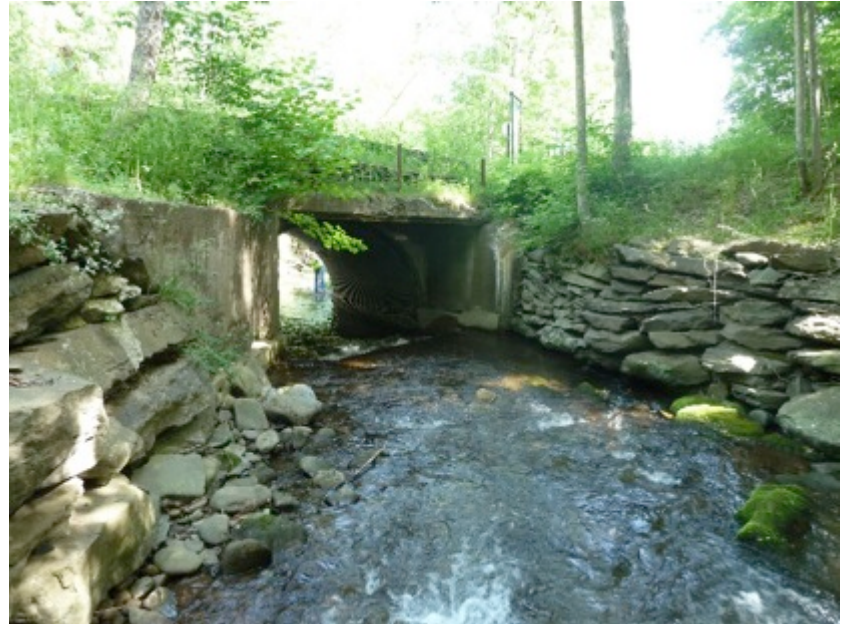
PH-4, view looking downstream at sewer crossing

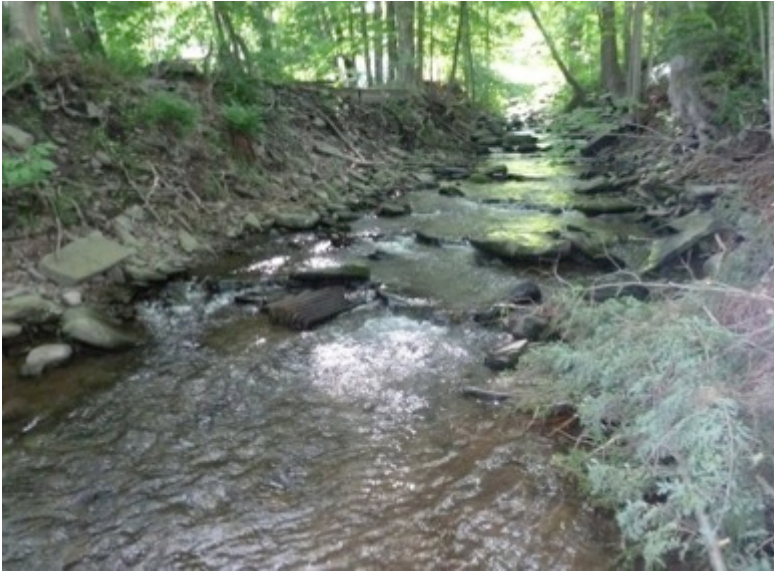
PH-6, view looking upstream from sewer crossing, steep eroded banks visible

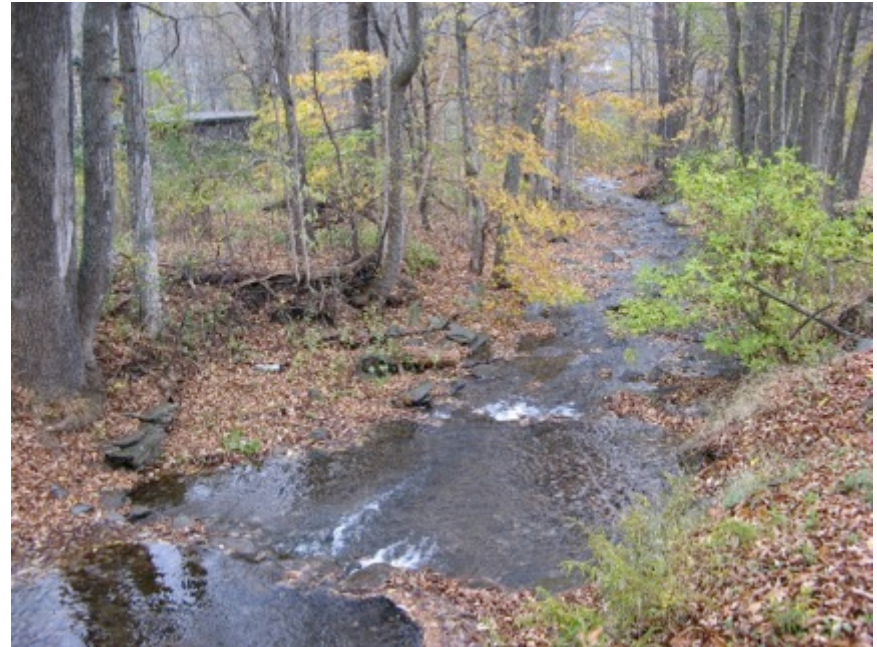
PH-6, view looking downstream from sewer crossing

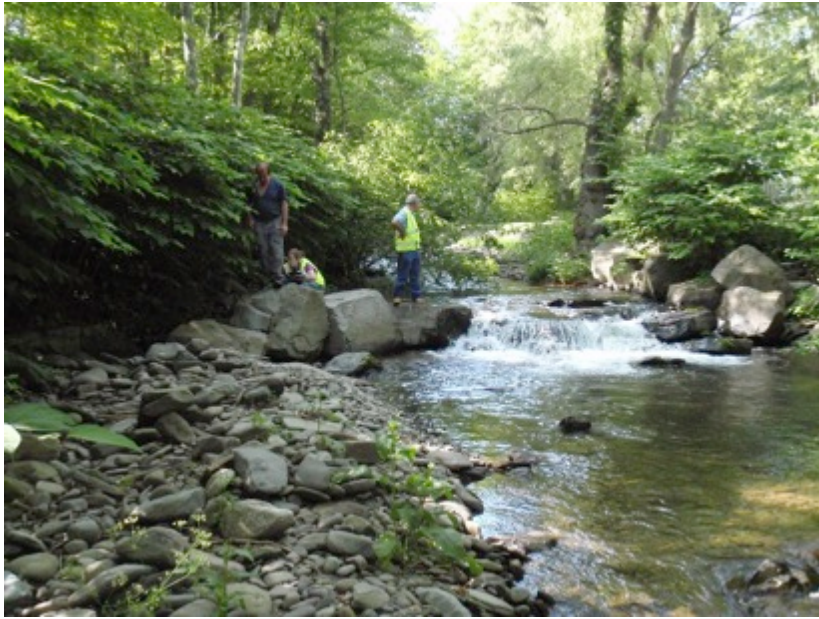
PH-5, view looking upstream at sewer crossing

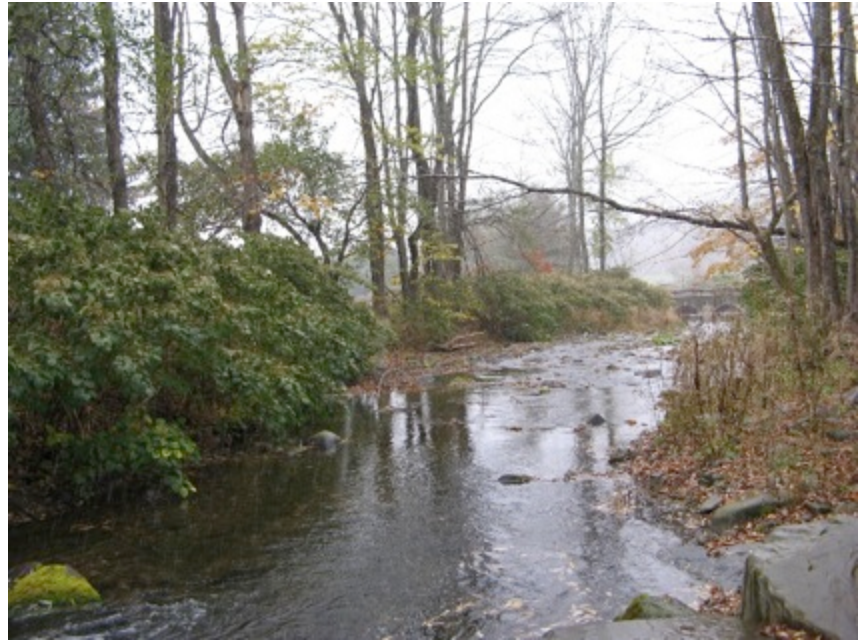
PH-5, view looking downstream from sewer crossing
