Wallkill River

Floodplain Bench Project – Phase 1

October 2016
Orange County

Barton
& Loguidice, D.P.C.

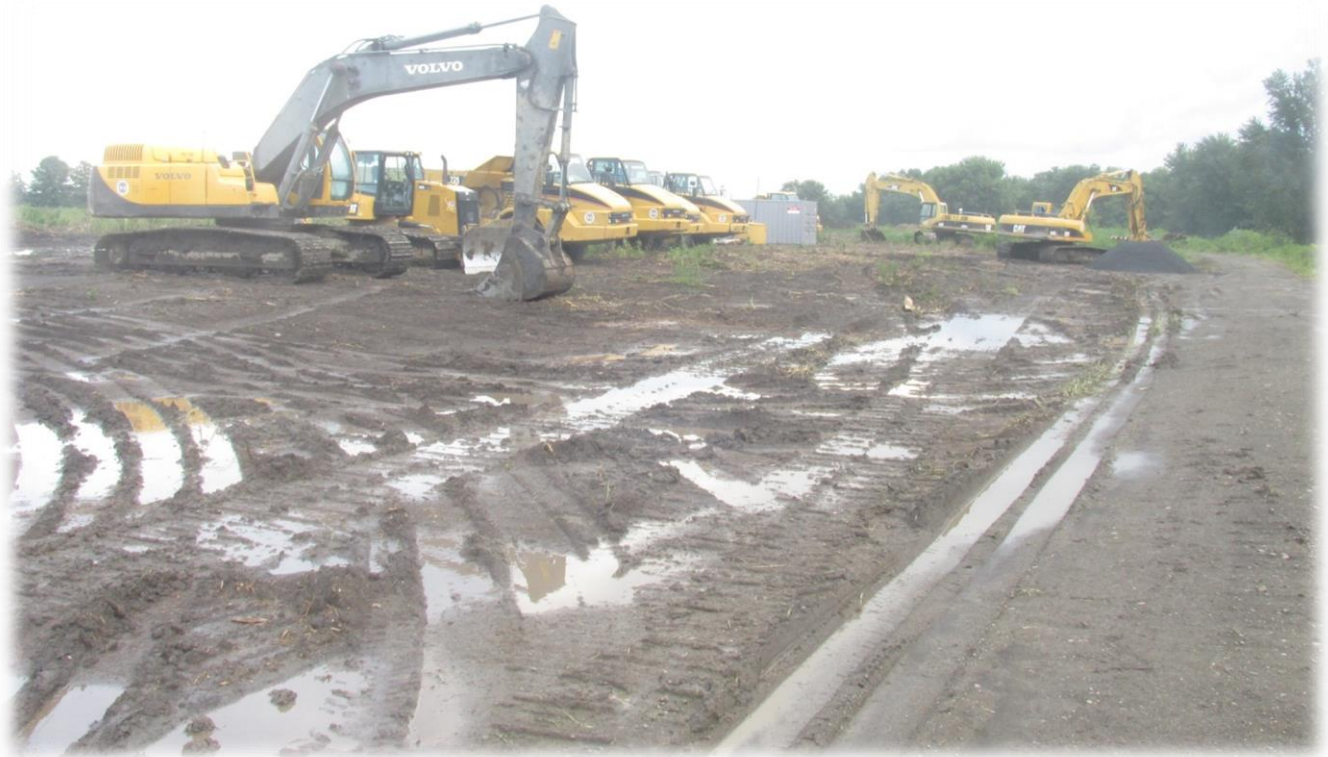
**Large work force with articulating end dumps
large capacity but not kind to soil**

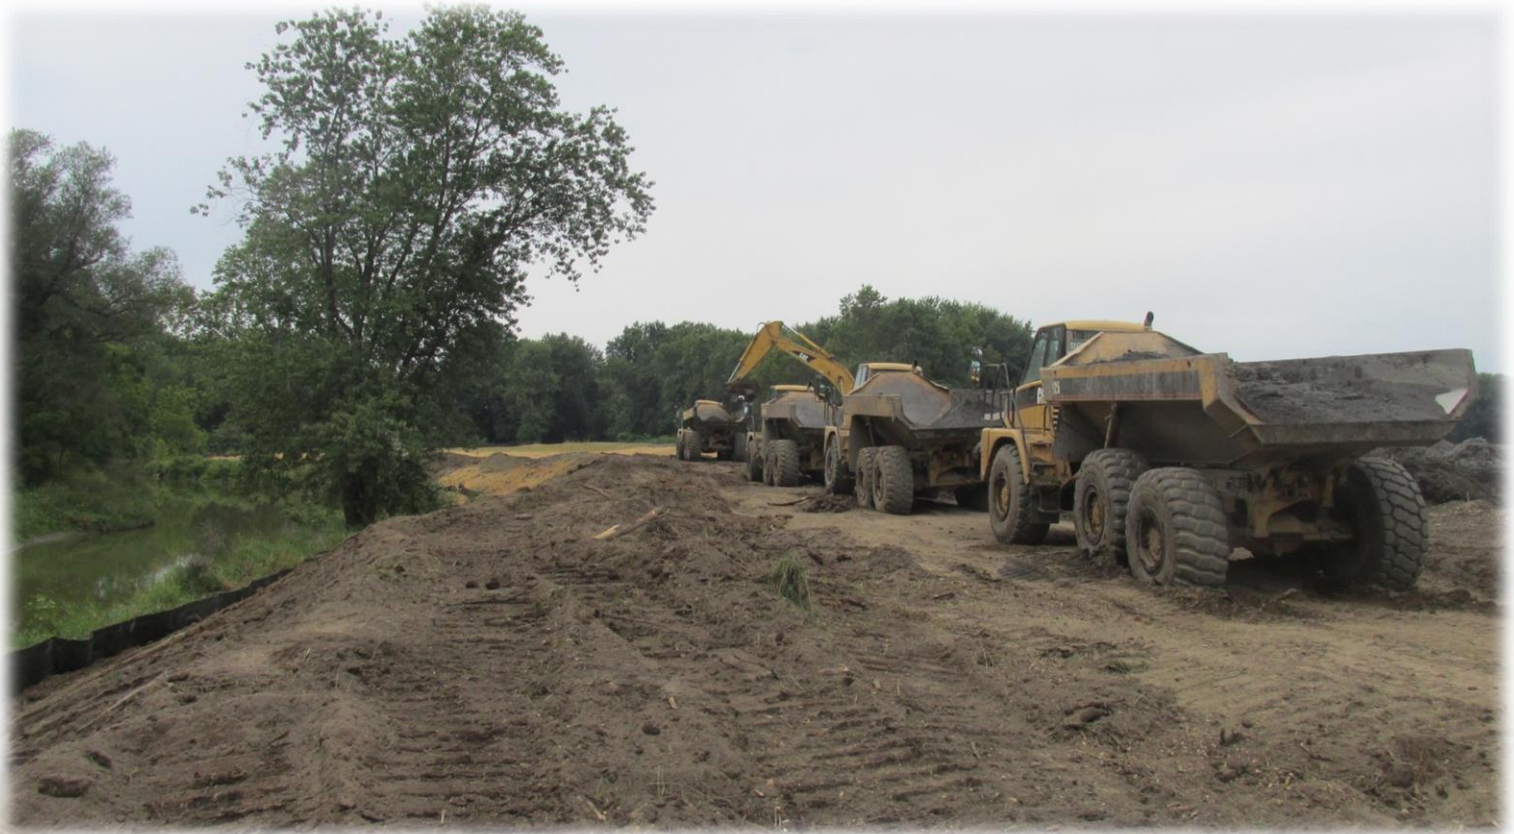
**Large work force with articulating end dumps
large capacity but not kind to soil**

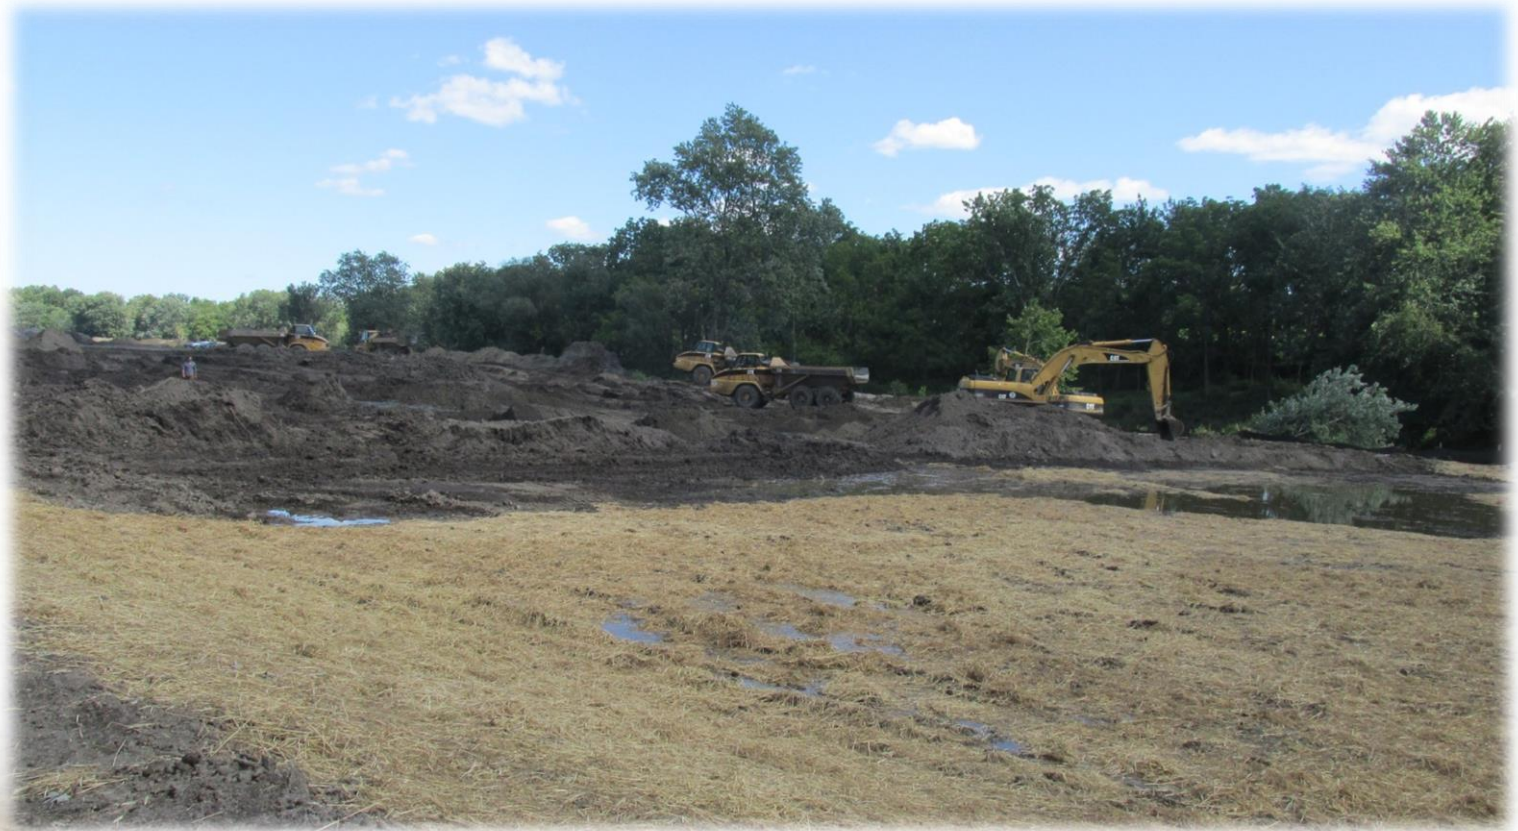
Wet working conditions, stabilization as work proceeds

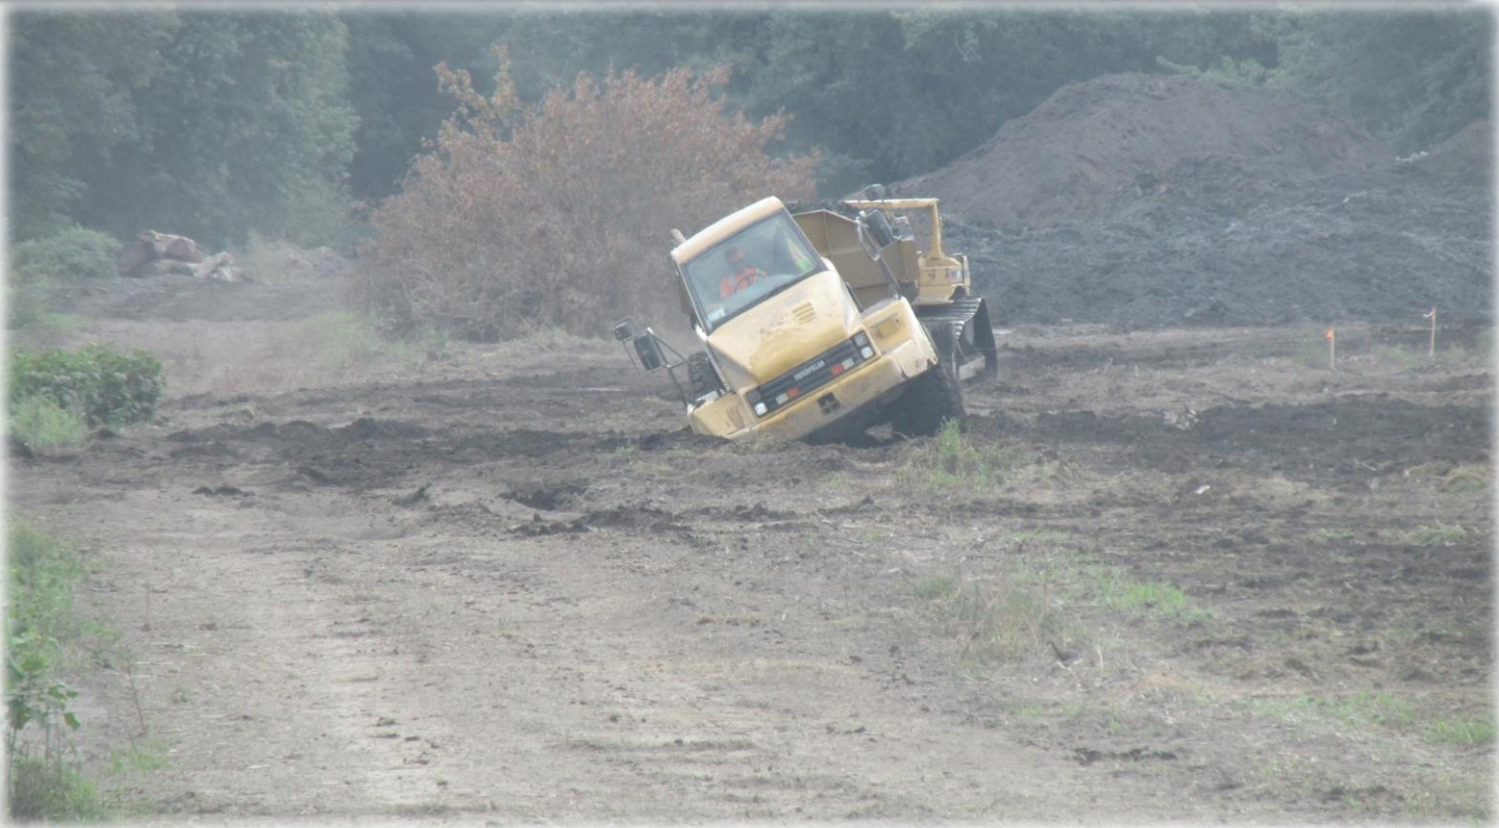
Challenging soil conditions

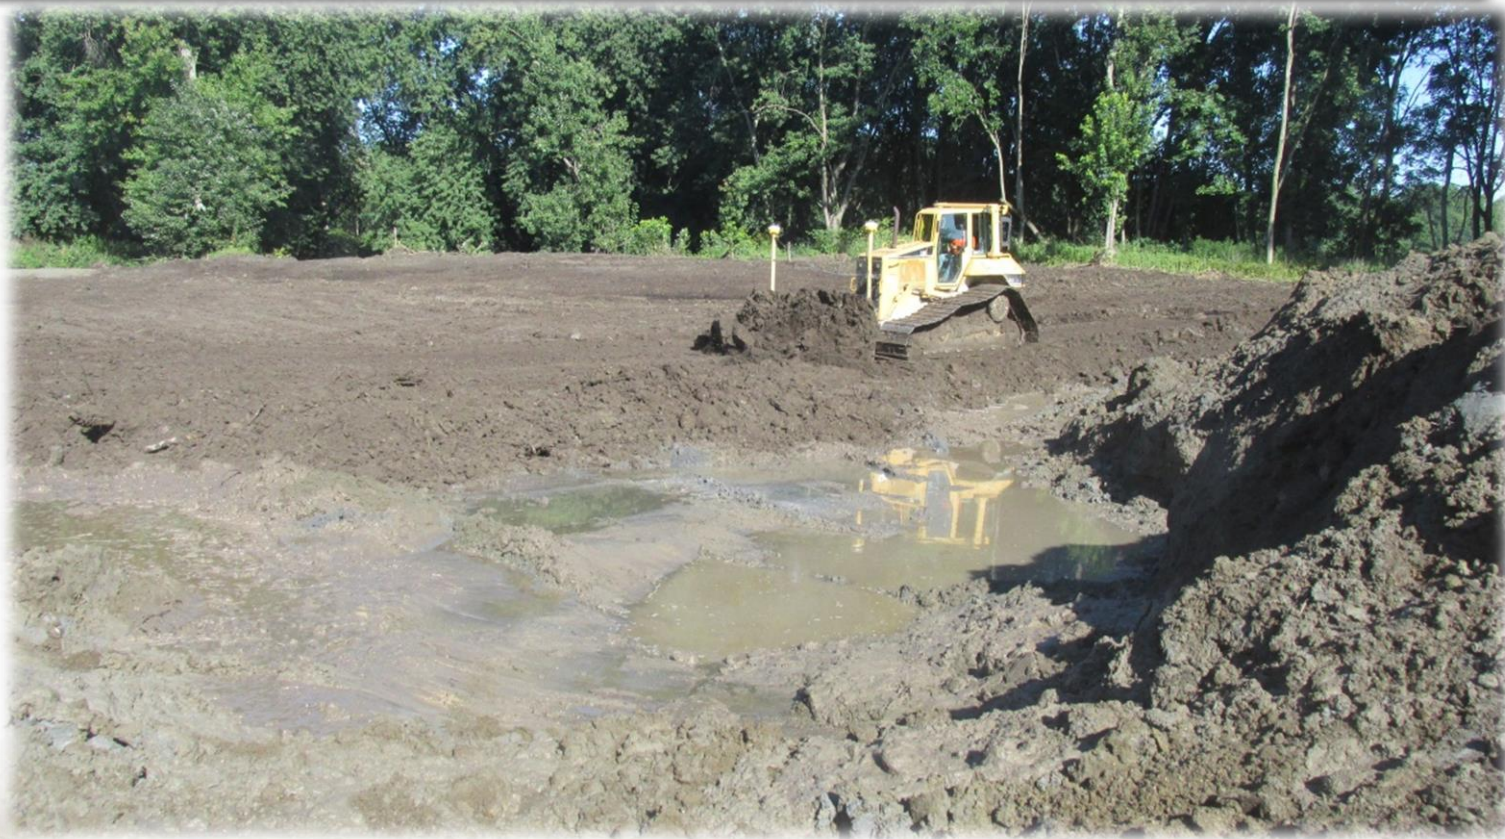
GPS controlled grading

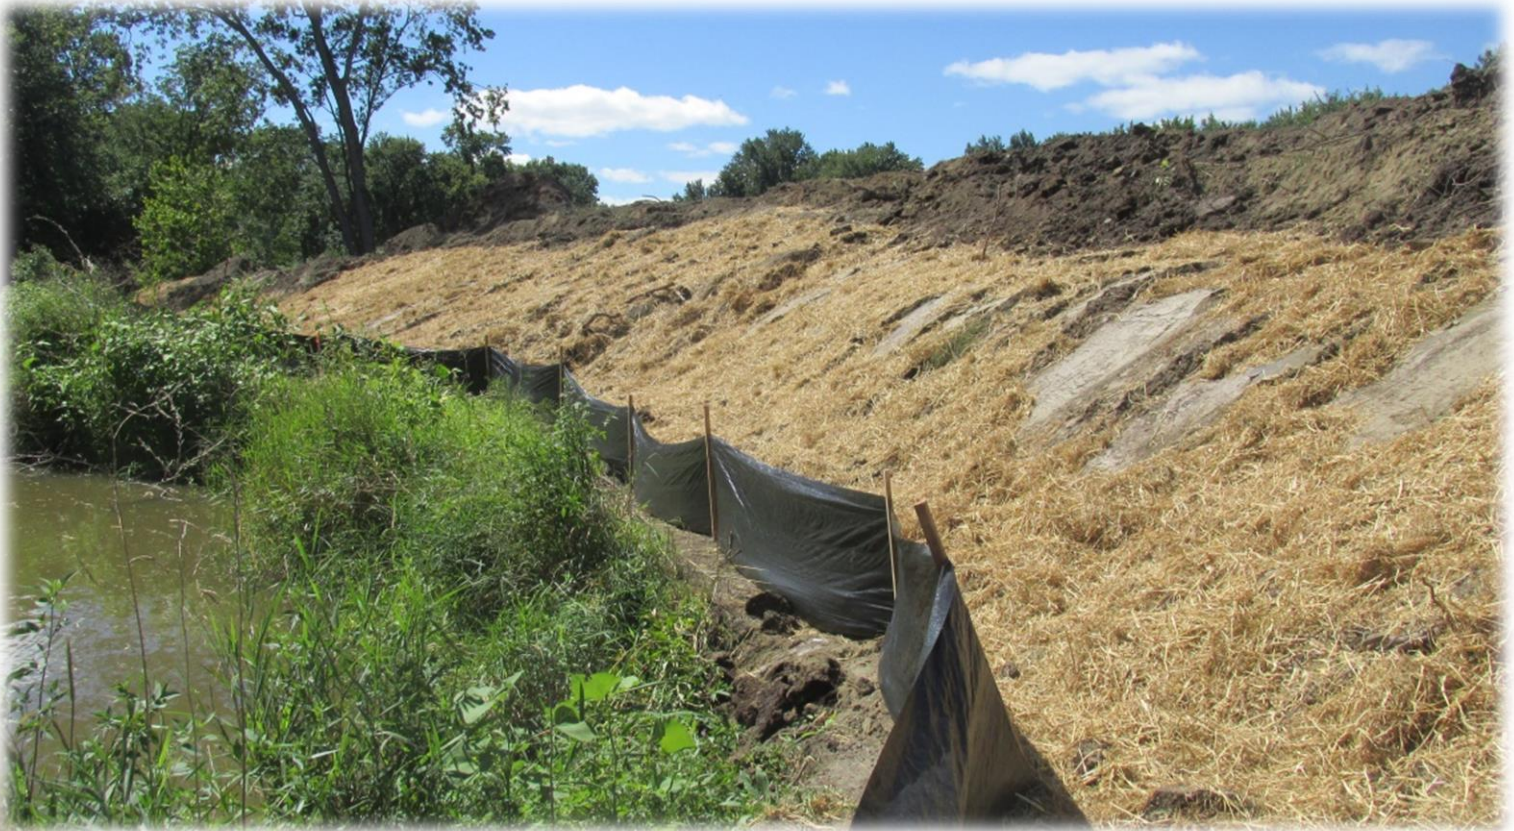
Acute erosion and sediment control concerns

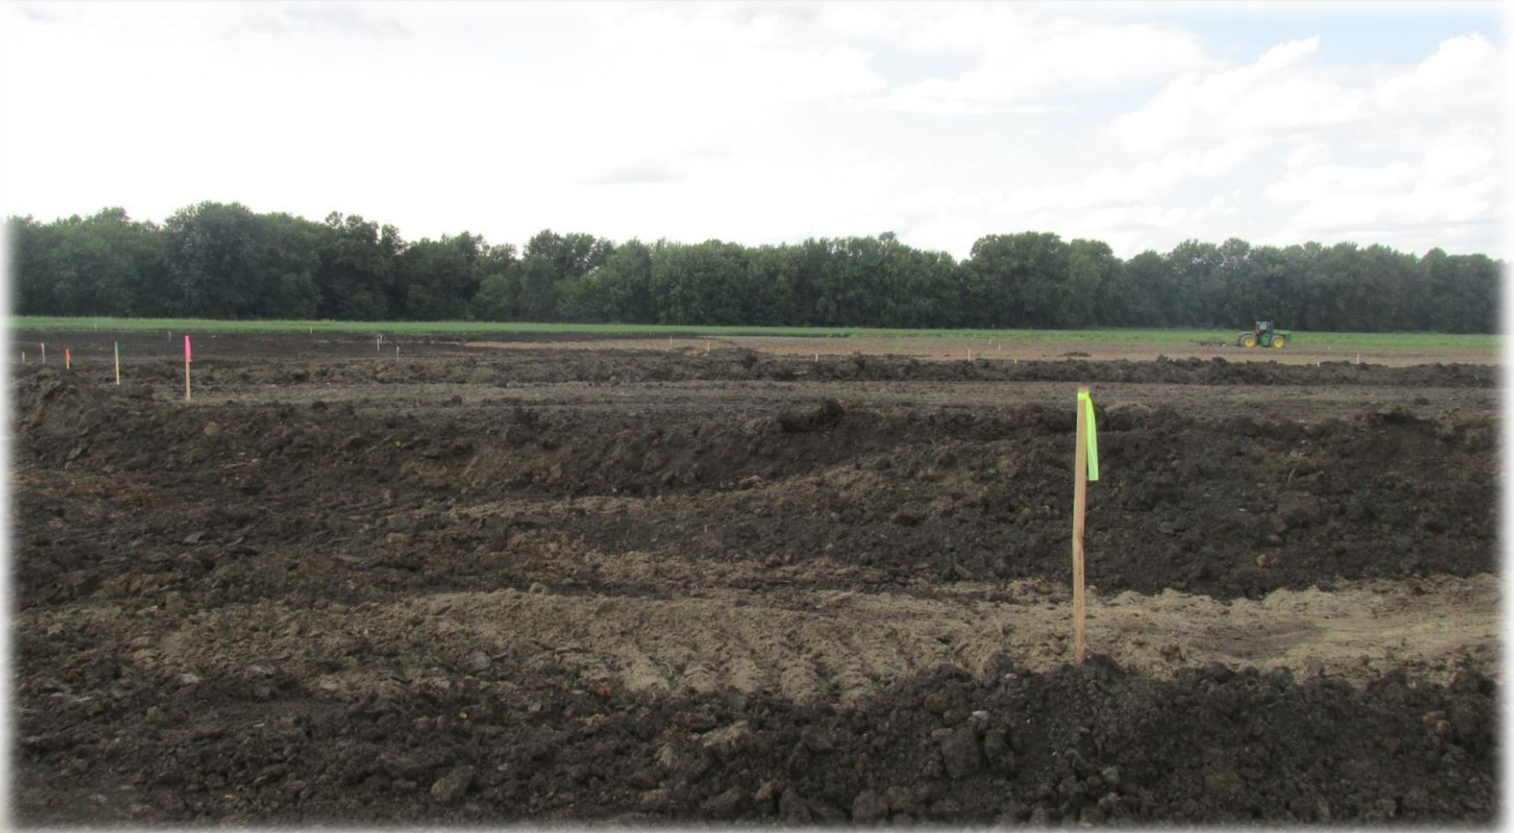
Soil from excavation used to improve adjacent farm fields according to grading plan

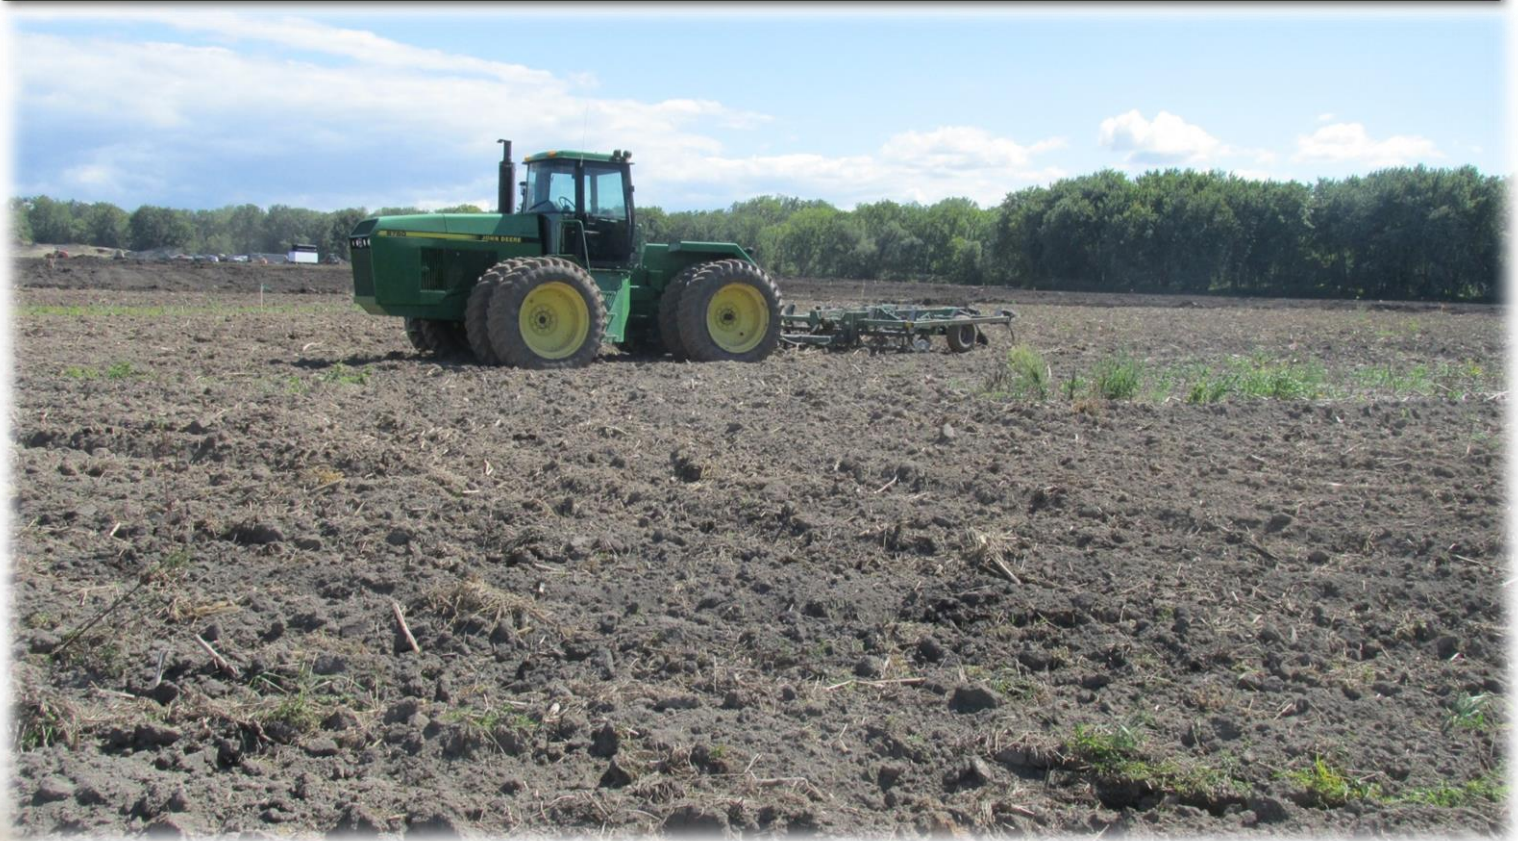
Farm field grading plan includes chisel plowing before and after new soil placement

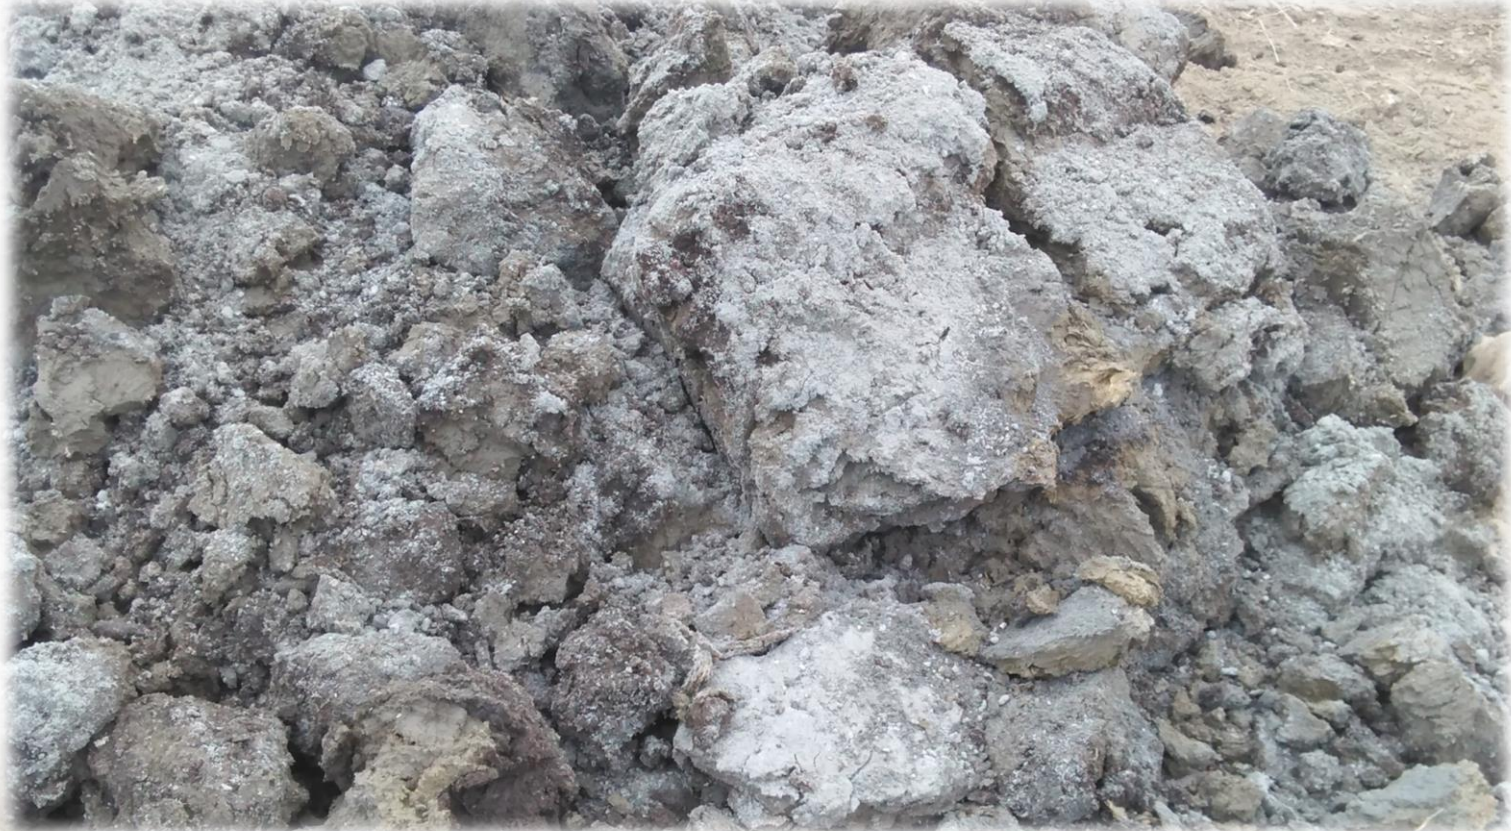
Complex soil layering including sedimentary peat

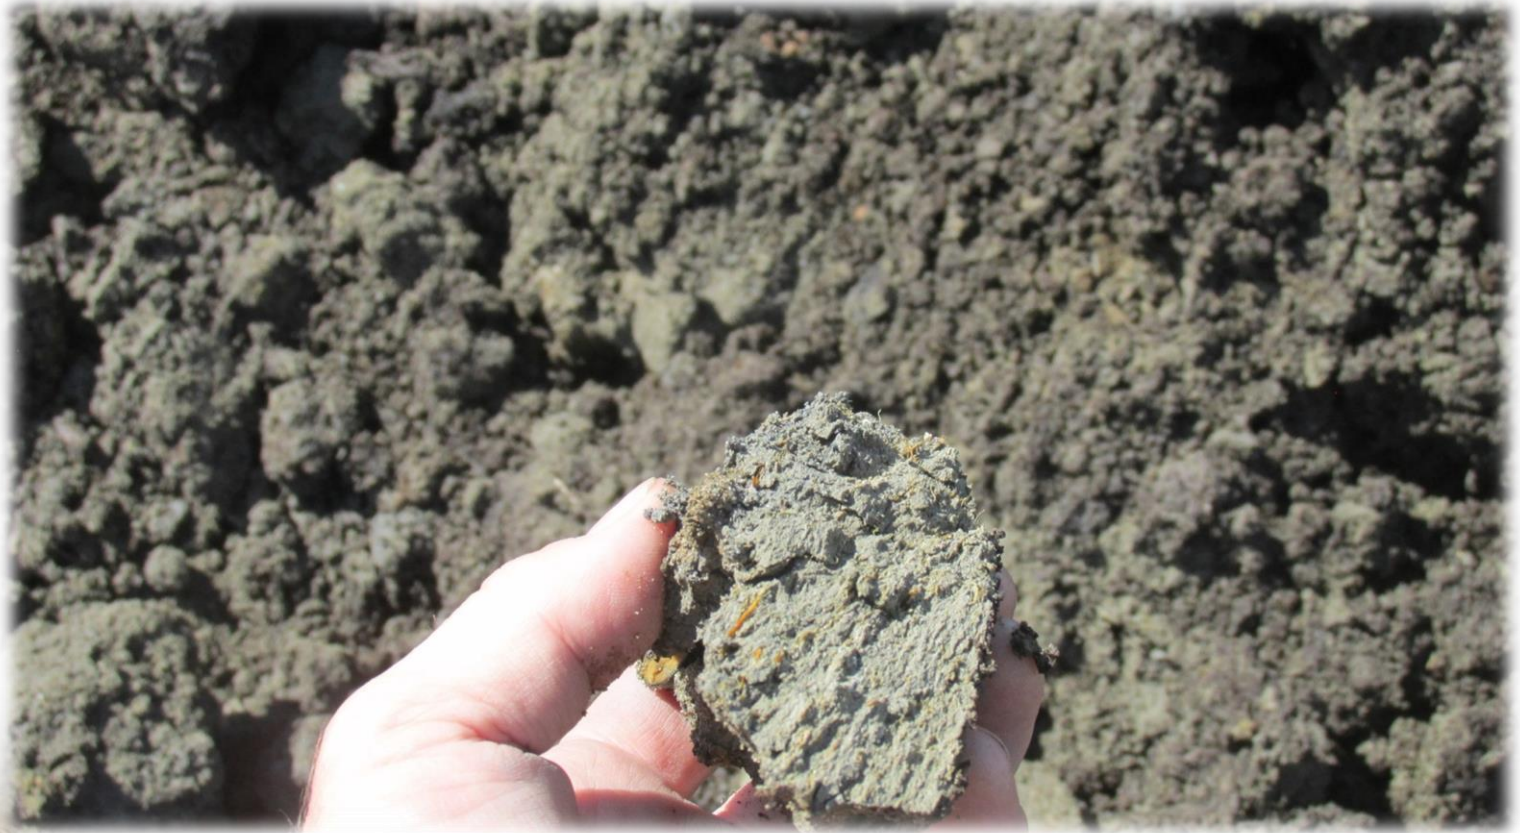
Complex soil layering including sedimentary peat

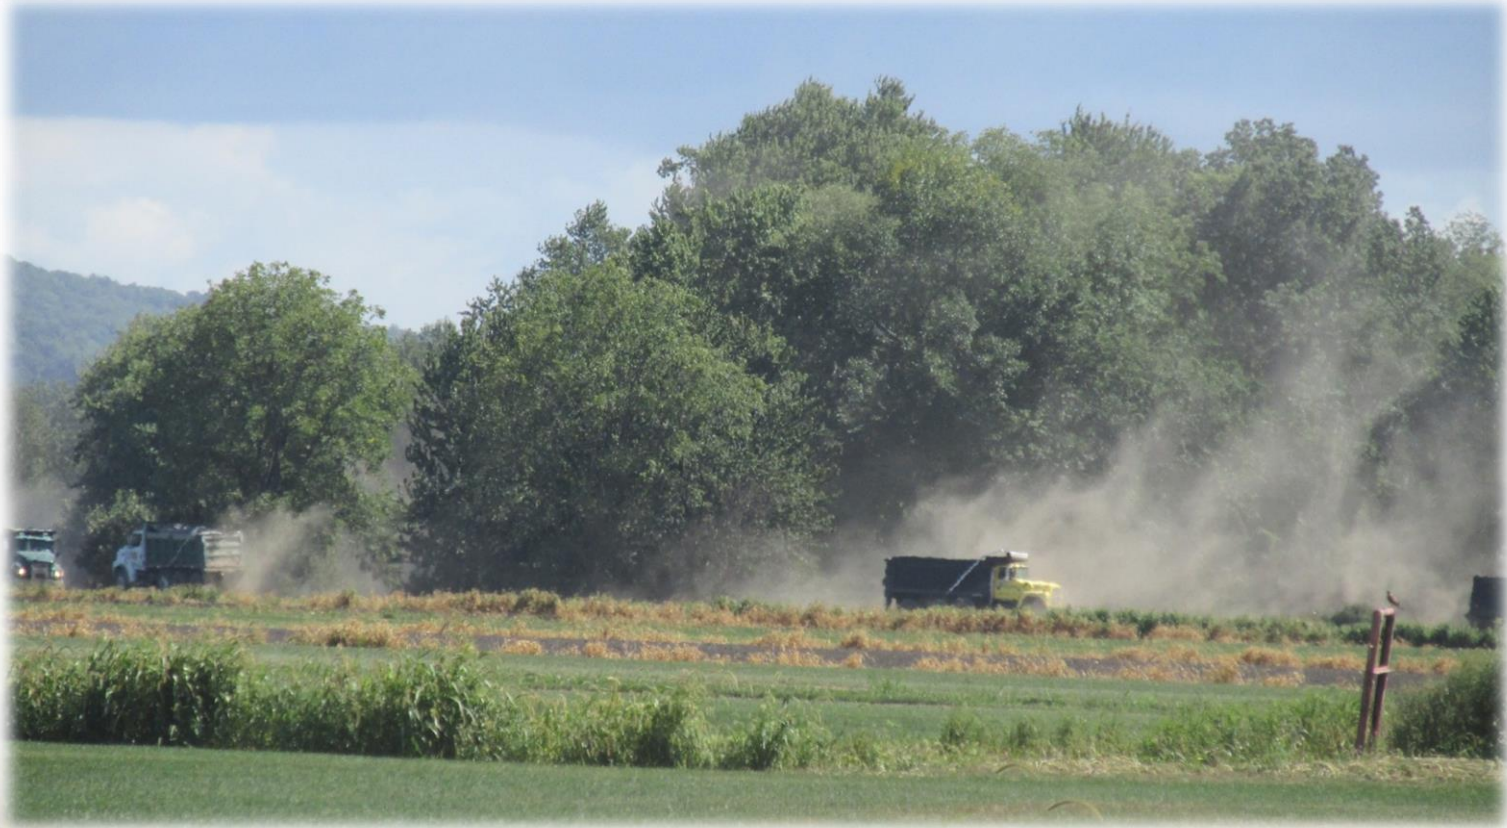
60,000 CY ~ 3,750 triaxle trips

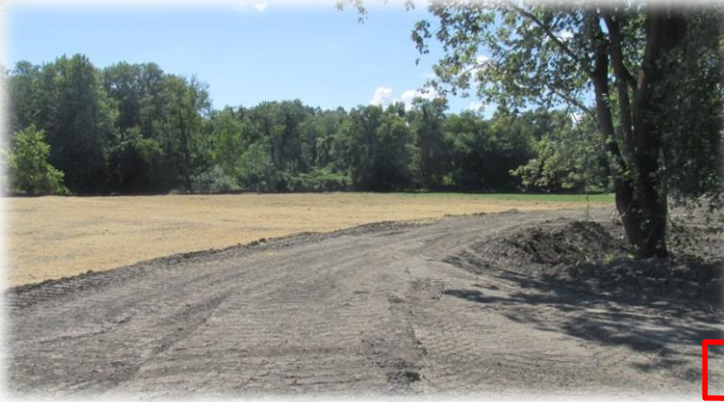
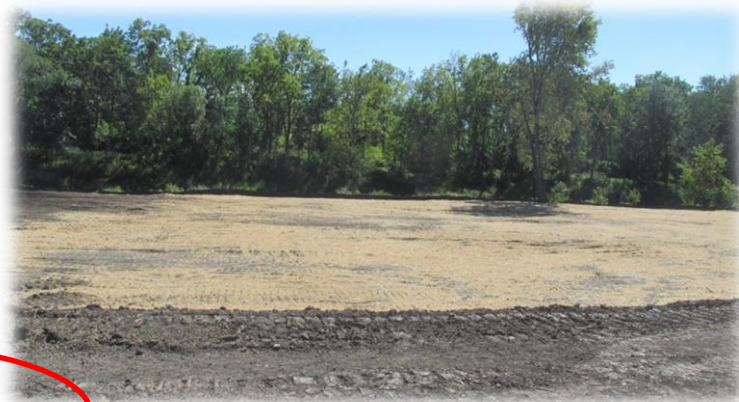
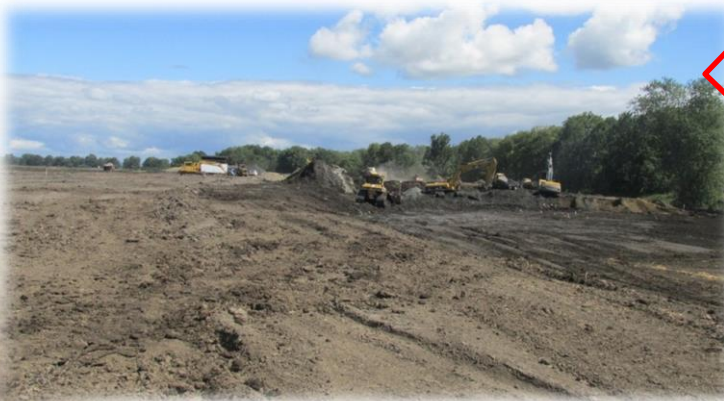
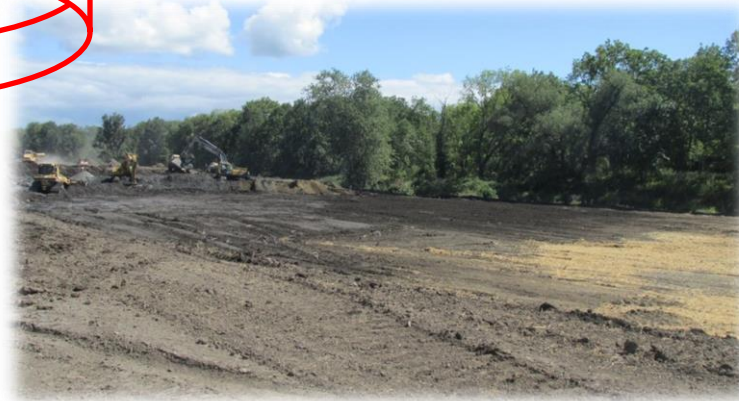
200 foot wide floodplain bench construction proceeds

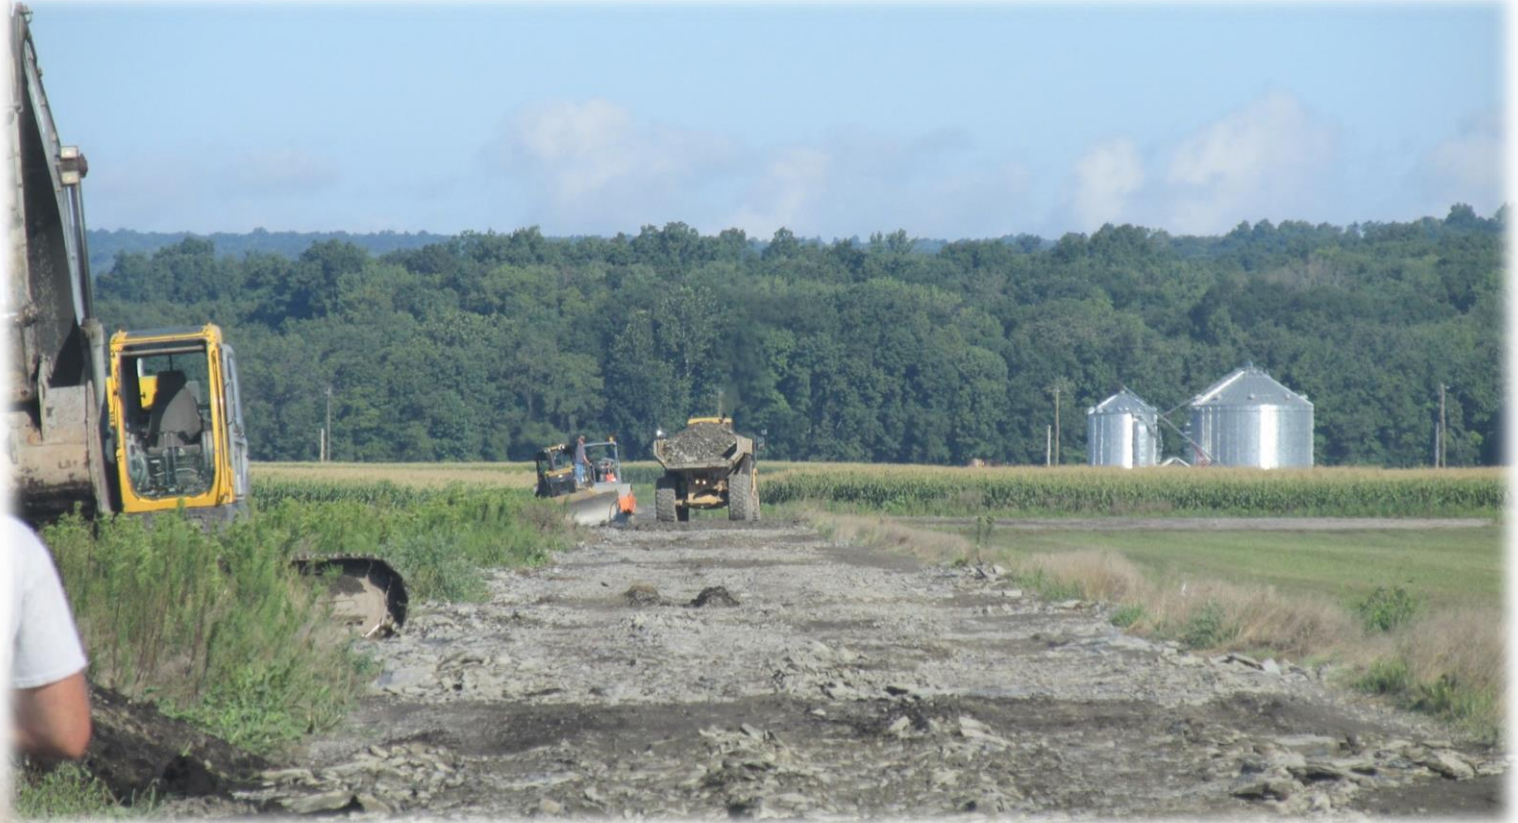
Truck traffic requires constant repairs to access roads

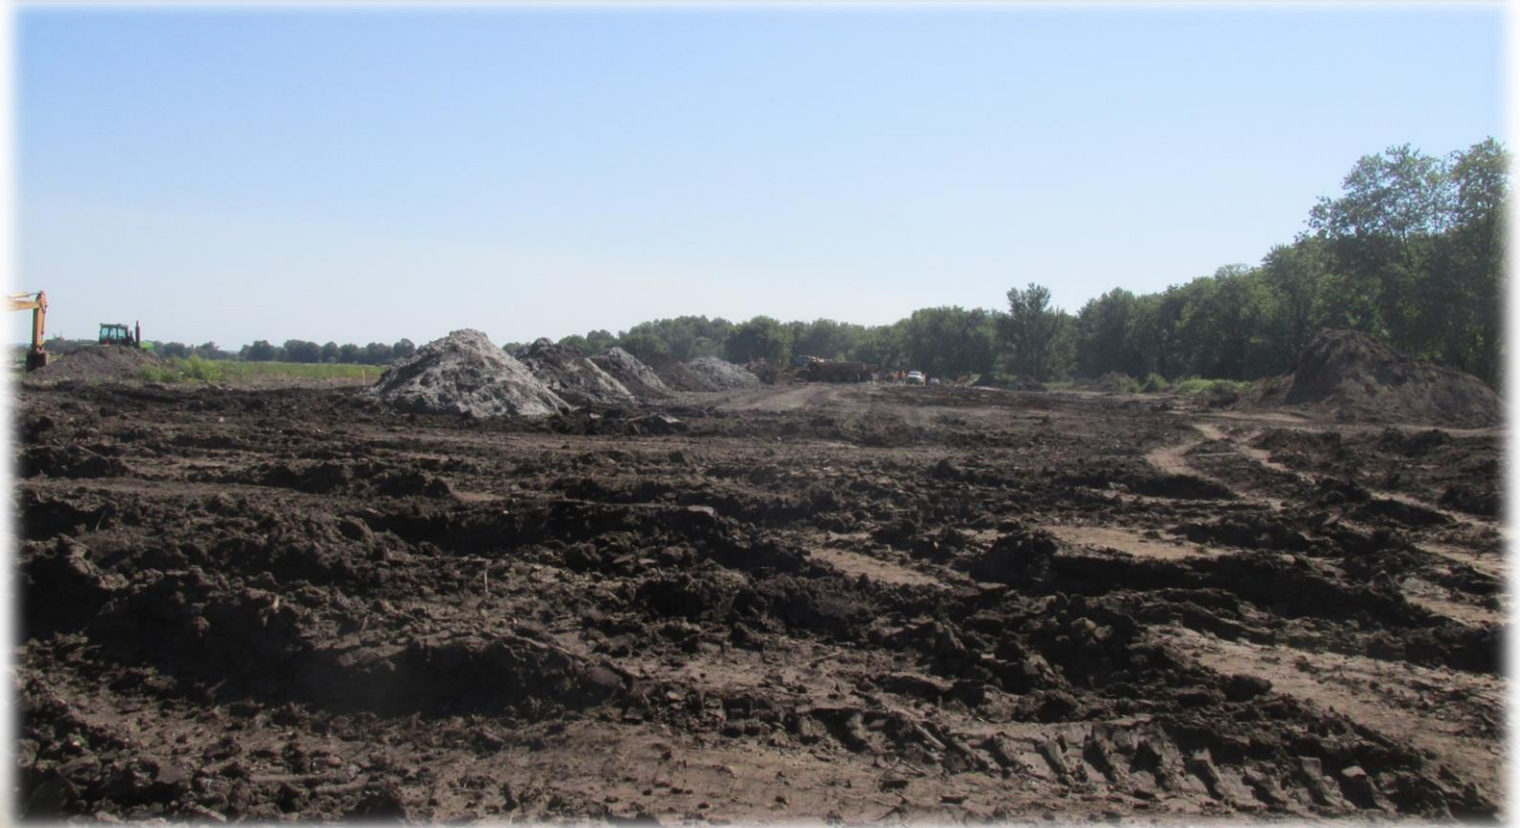
Segregating soil material

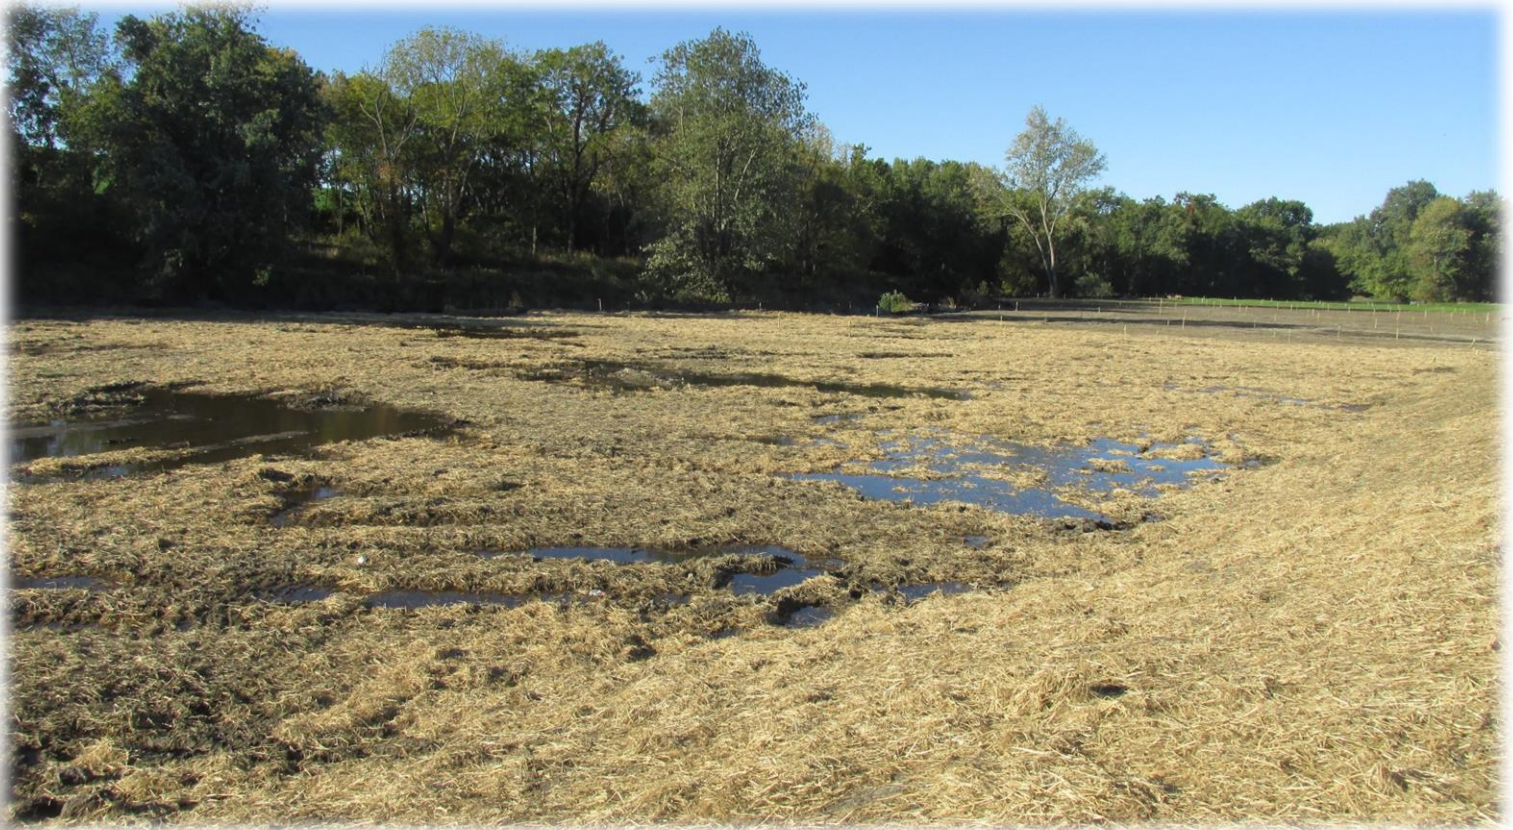
Wet bench issues
