Assessing Green Infrastructure: Kingston Uptown Parking Lots

Emily Vail

Hudson River Estuary Program,
NYS Department of Environmental Conservation
NYS Water Resources Institute at Cornell University

October 18, 2017

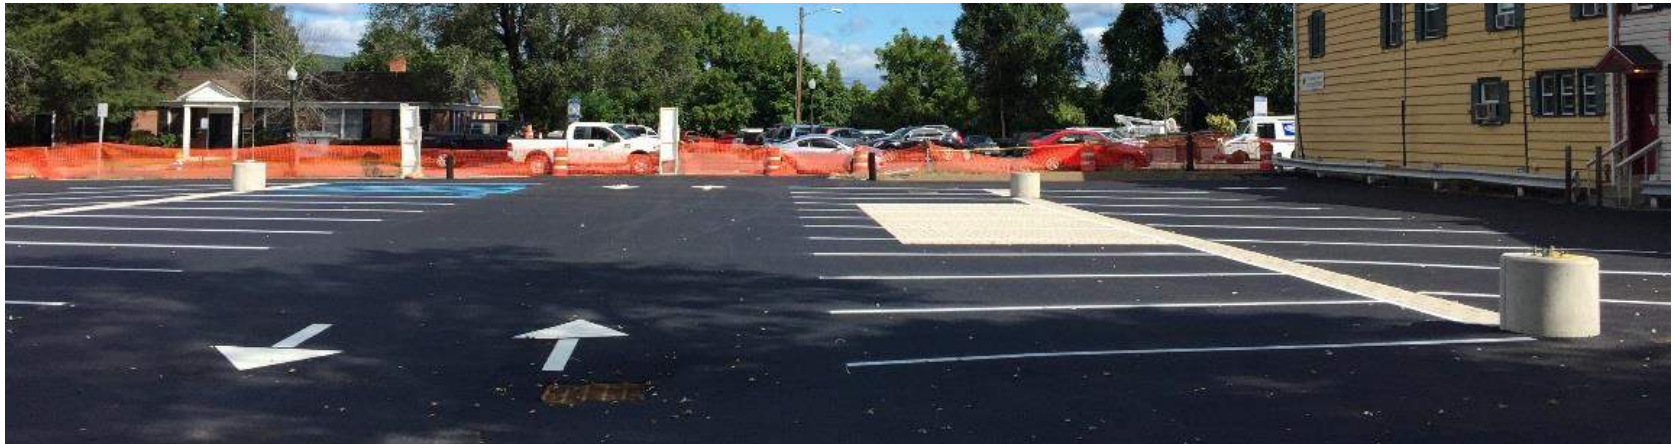
Dry Well

Bioretention

Pervious Pavers

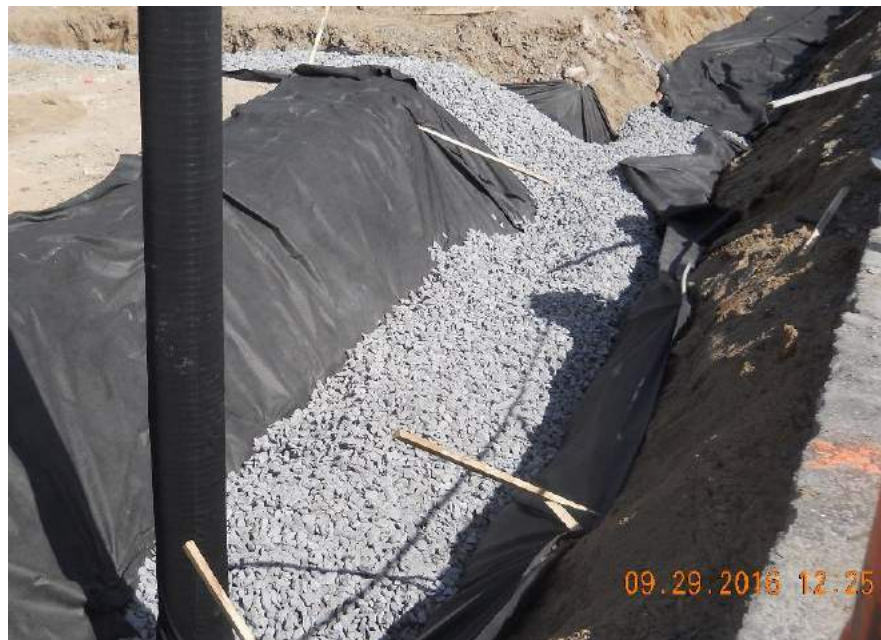
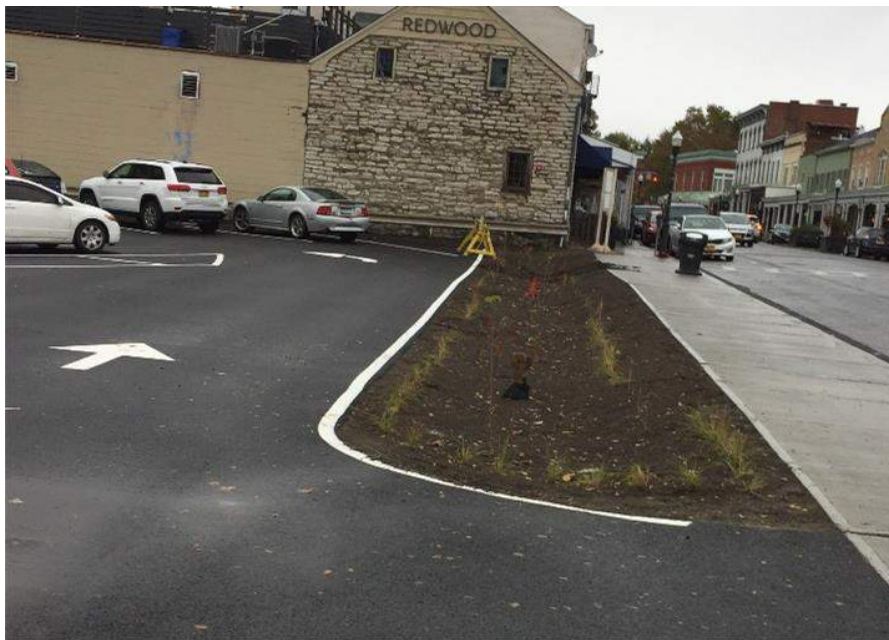
Bioretention Areas – with underdrain

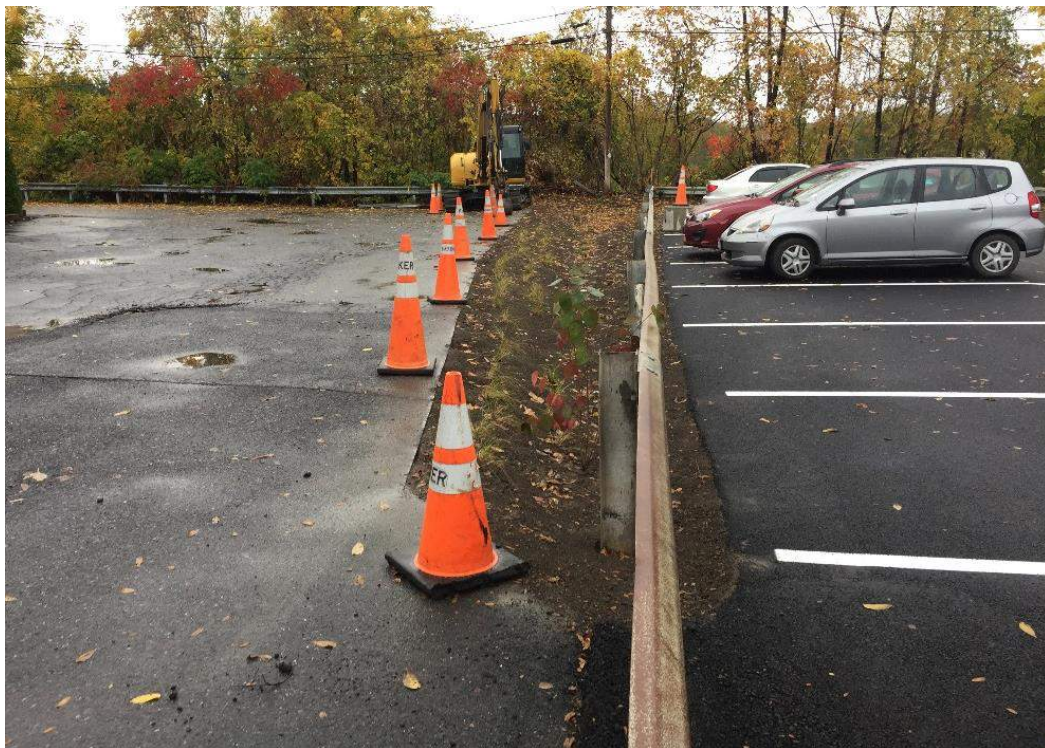
Bioretention Areas – without underdrain

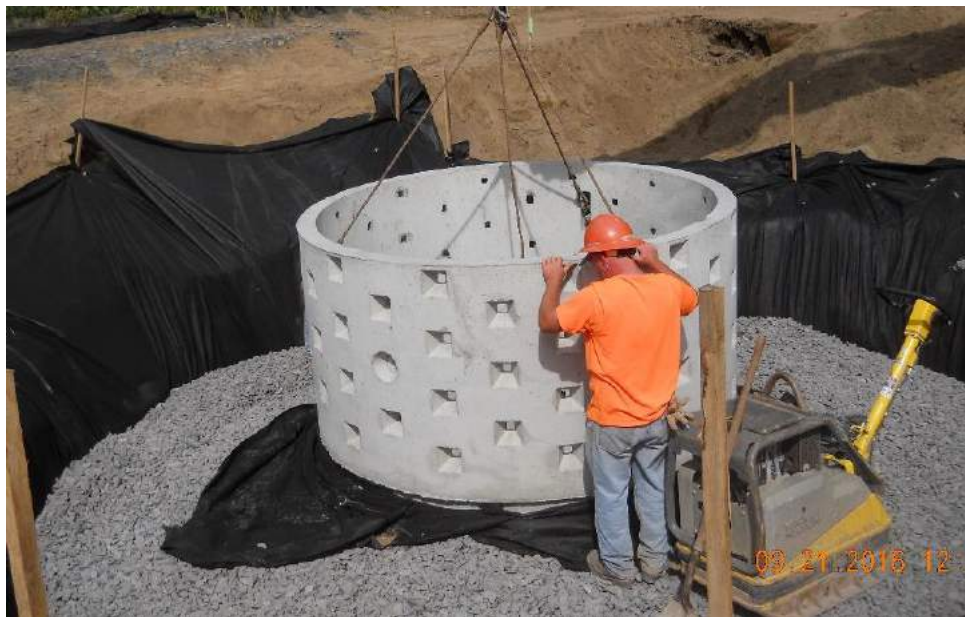
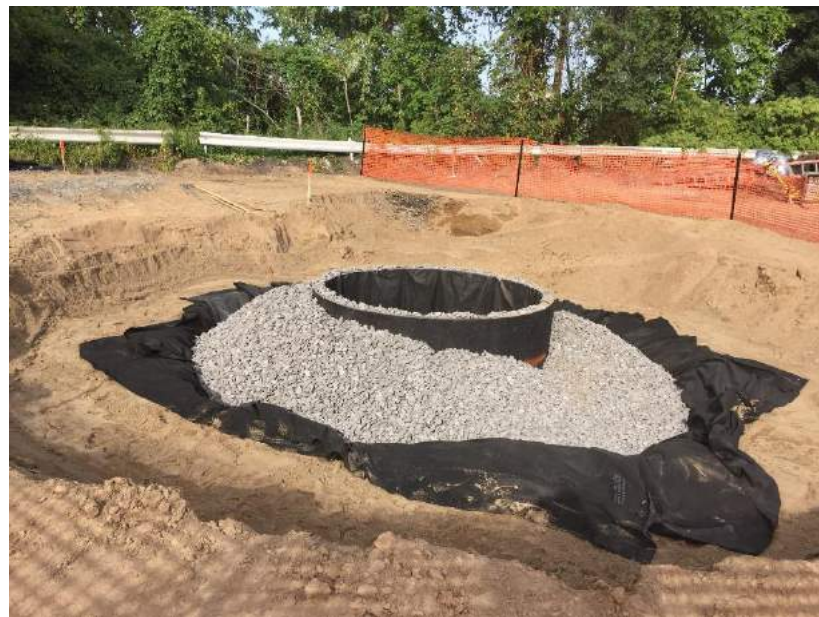
Dry Wells

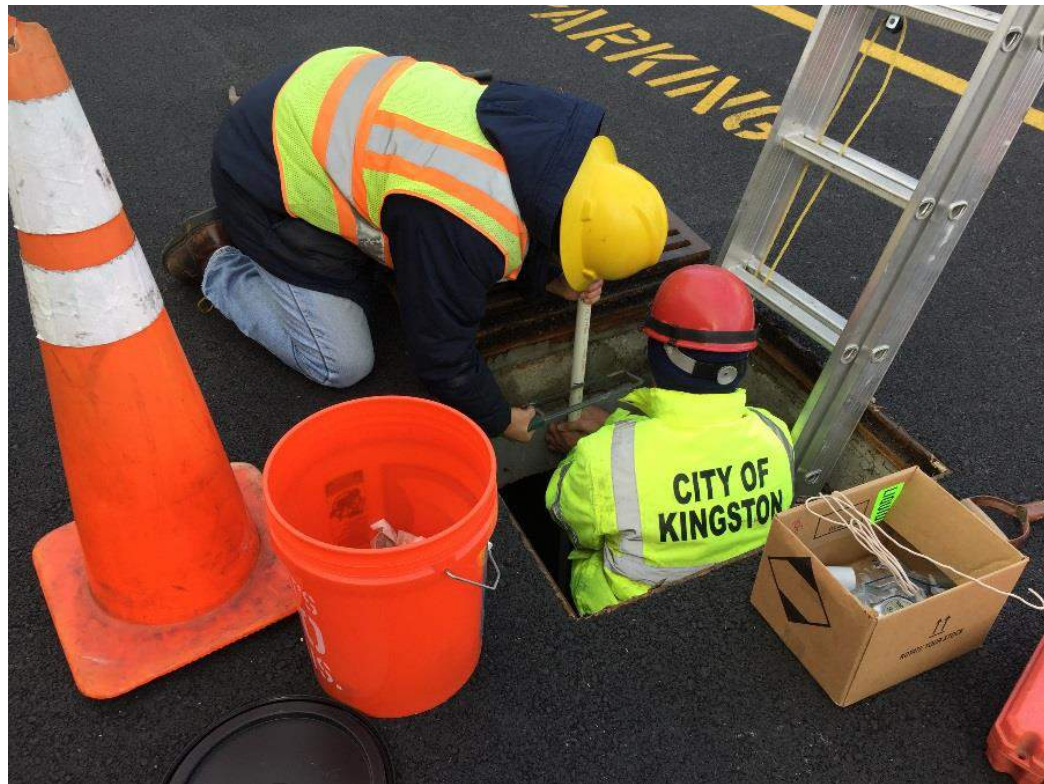
HOBOS in Bioretention Areas, no underdrain

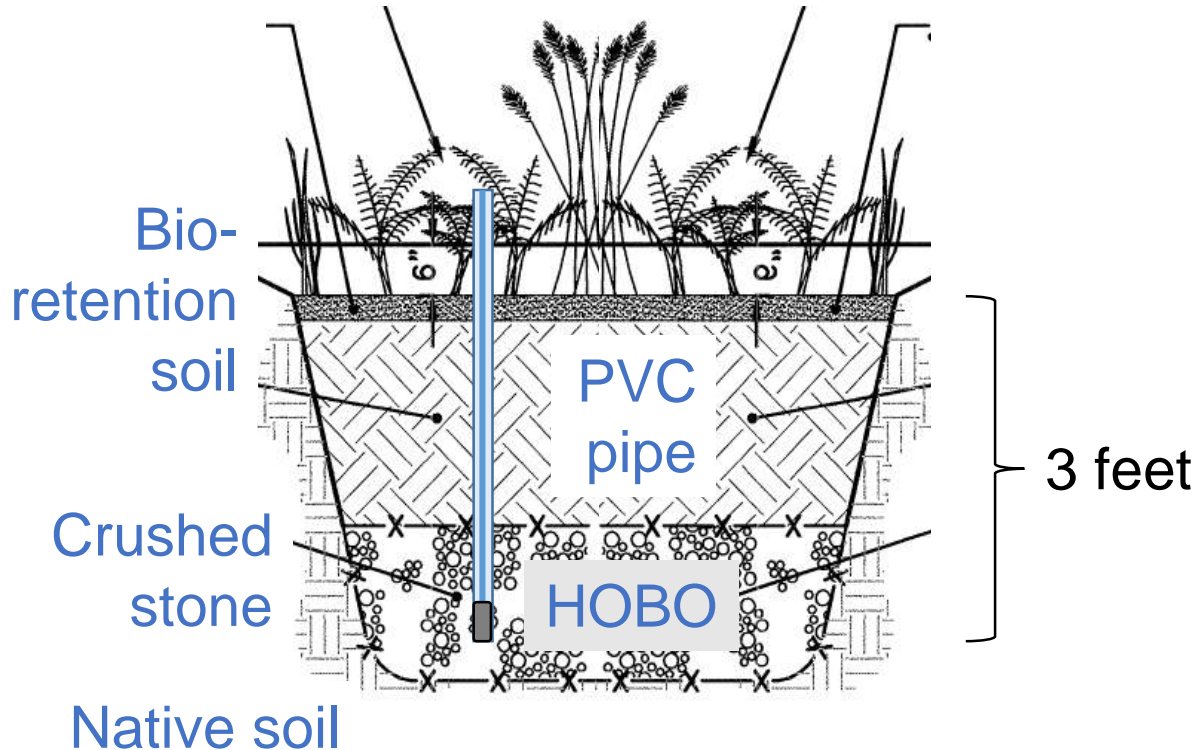
HOBOS in Bioretention Areas, no underdrain

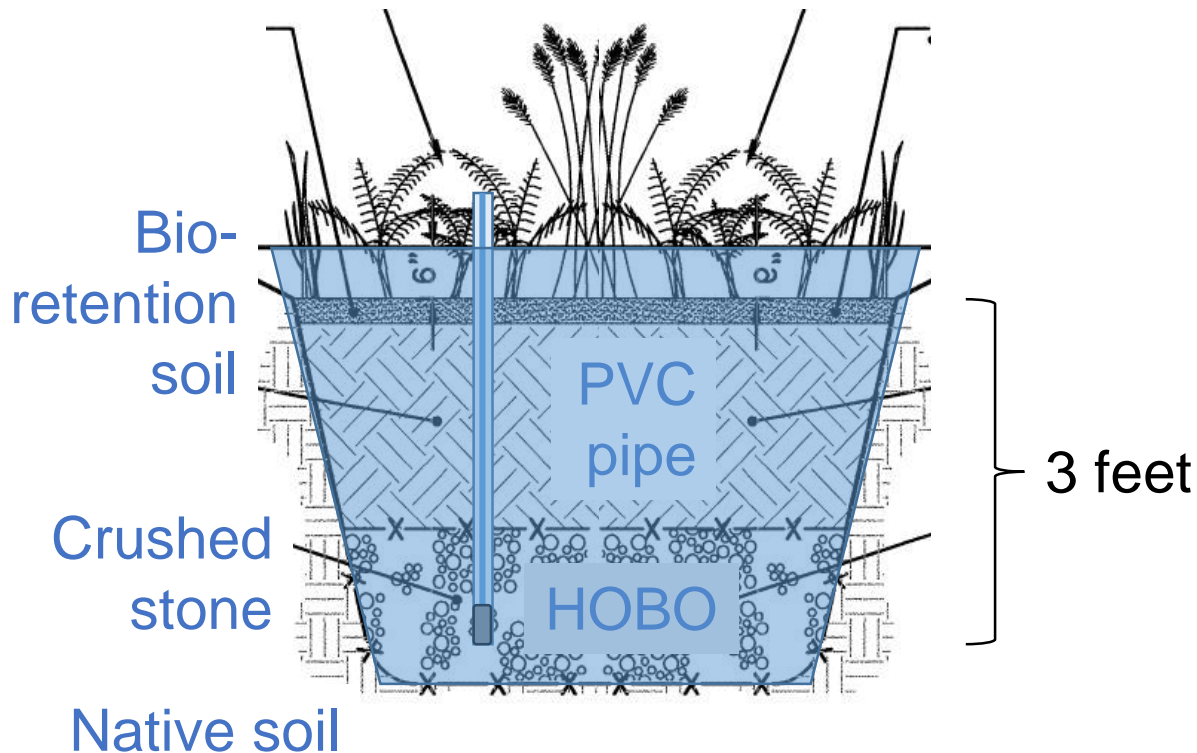
HOBOS in Bioretention Areas, underdrain

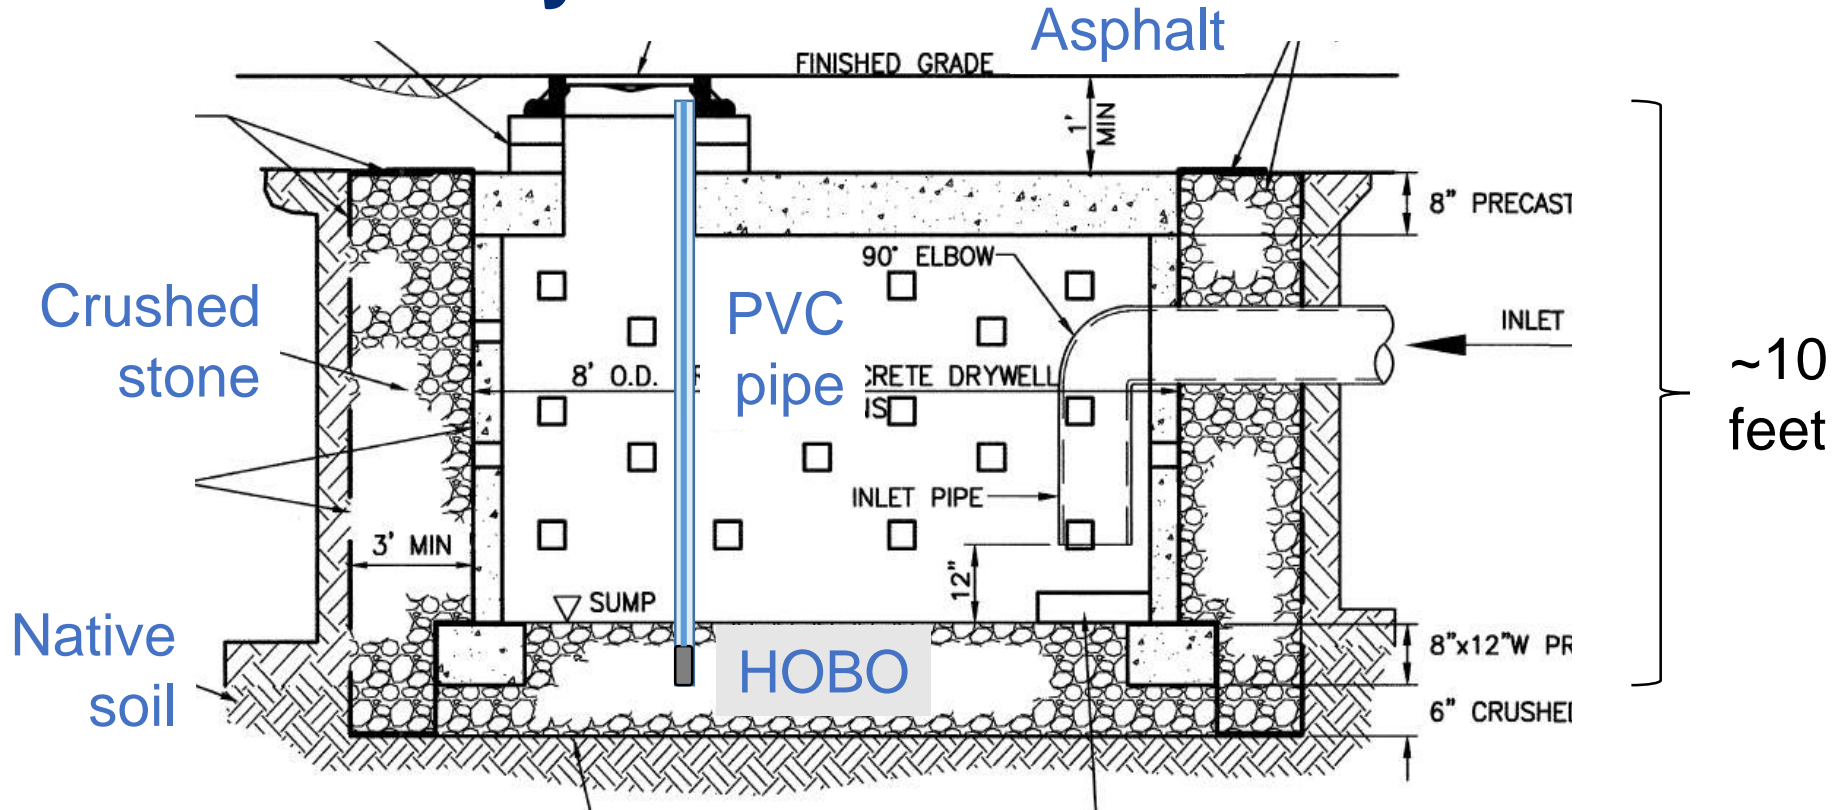
HOBOS in Dry Wells

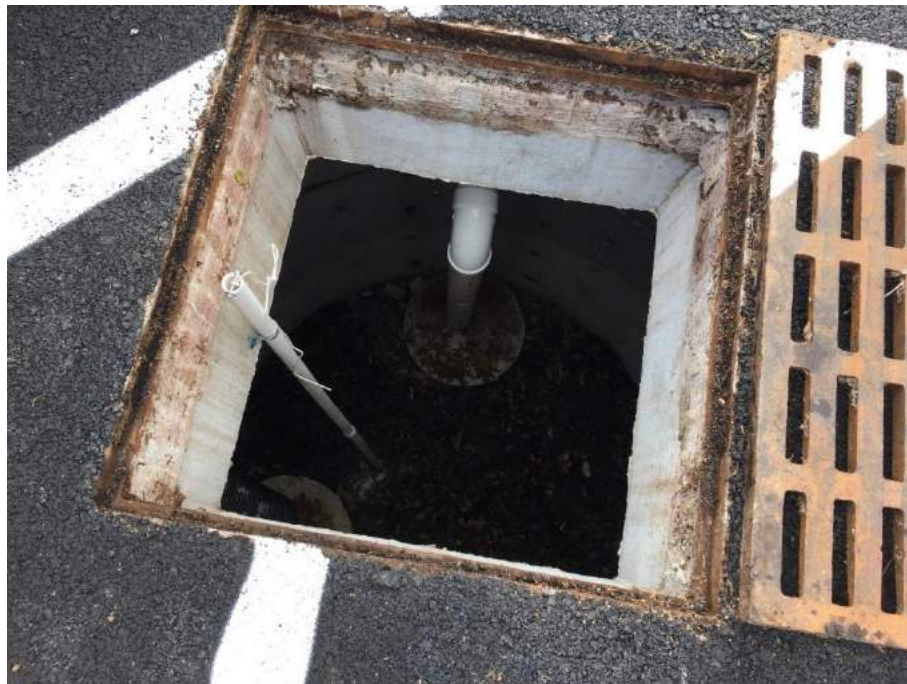
PVC pipe for HOBO in dry well

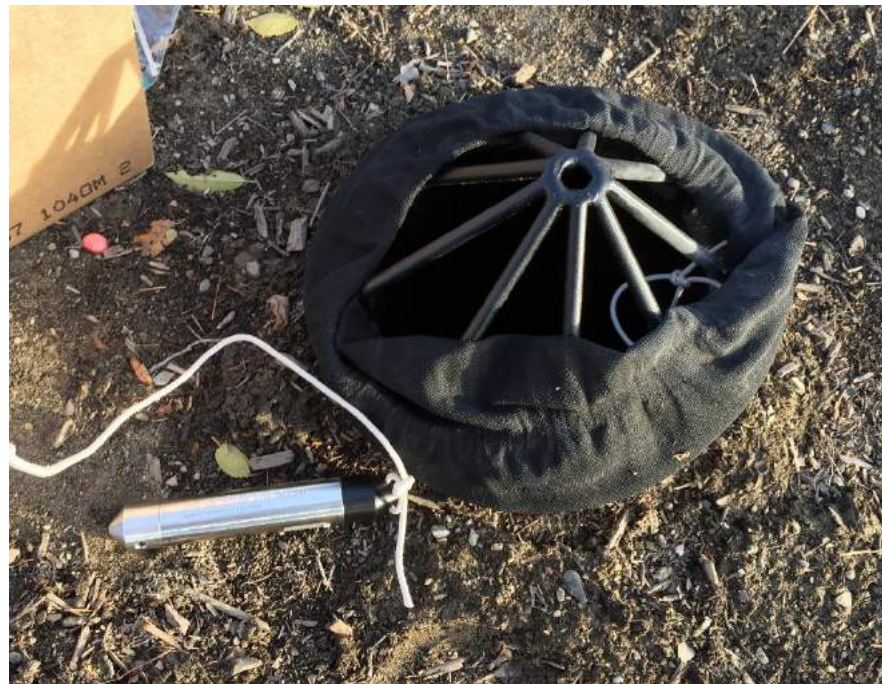
HOBO in bioretention underdrain

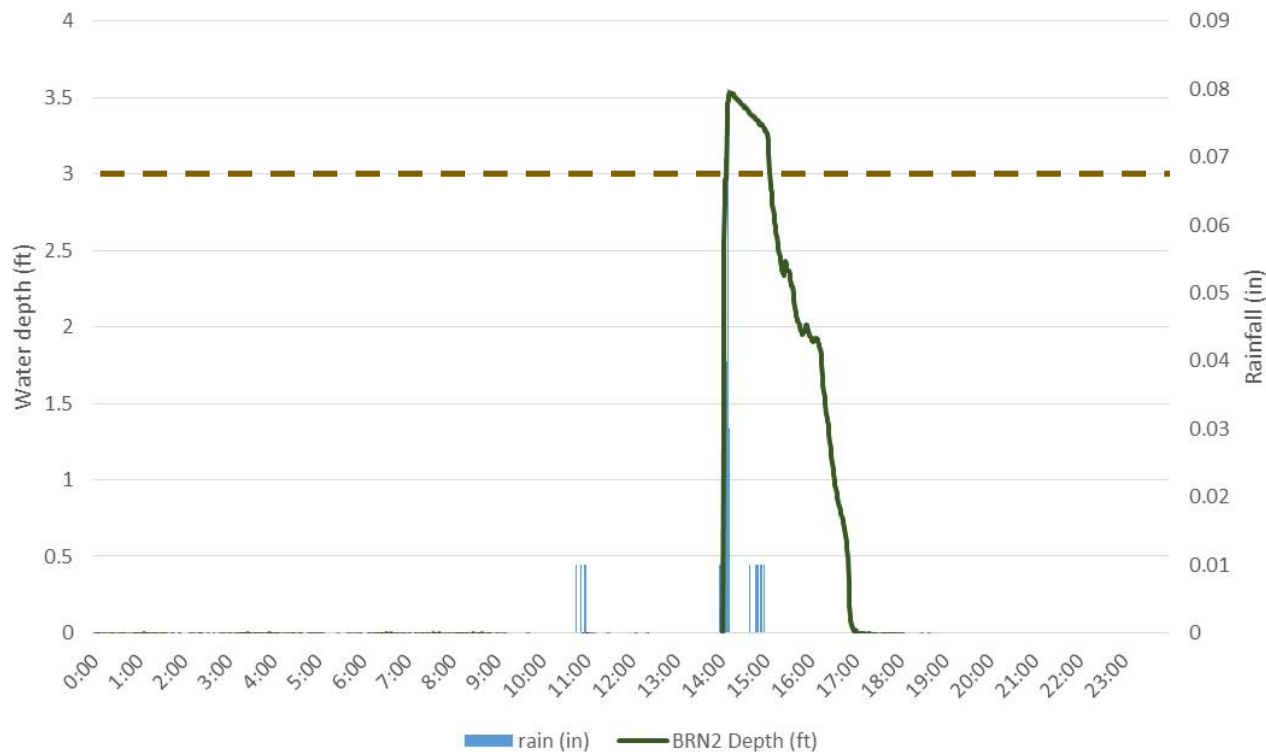
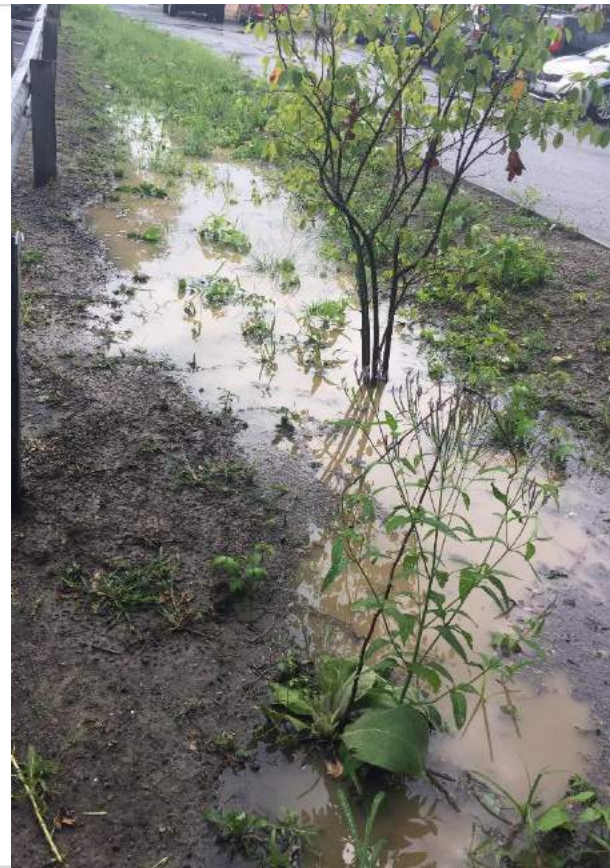
Bioretention North 2 - August 4, 2017

Bioretention Areas without Underdrain

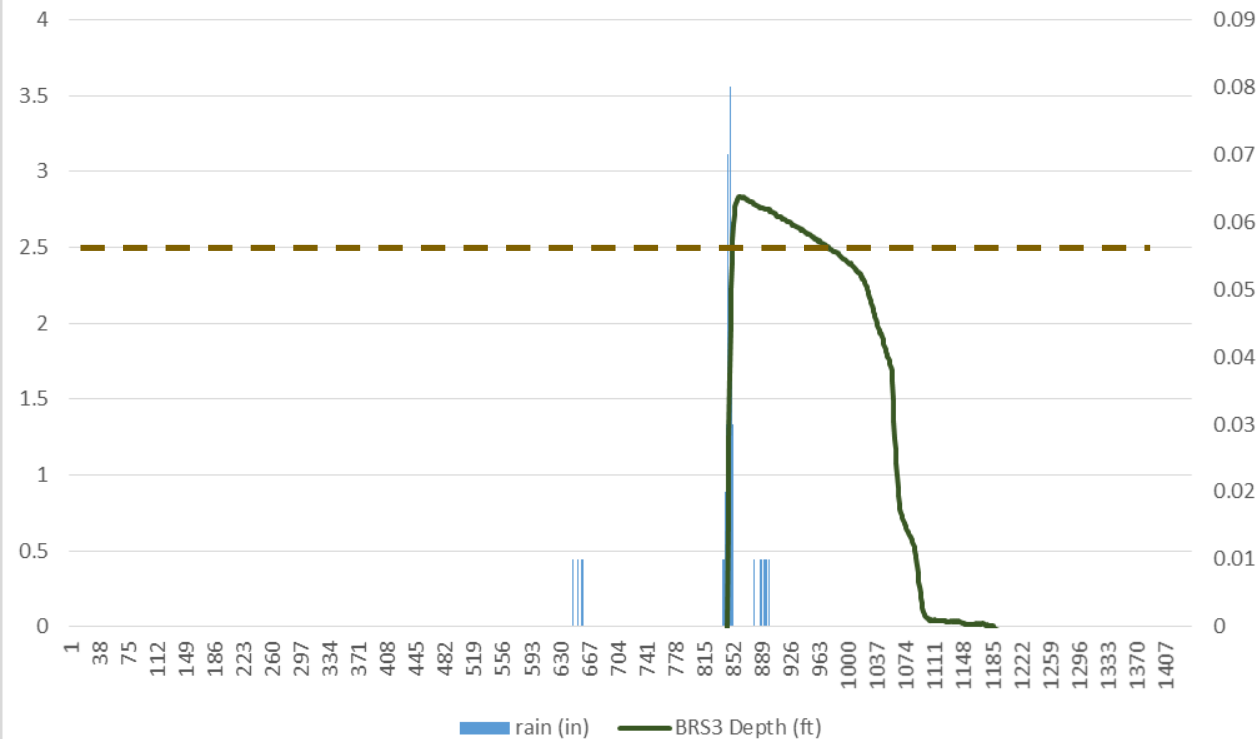
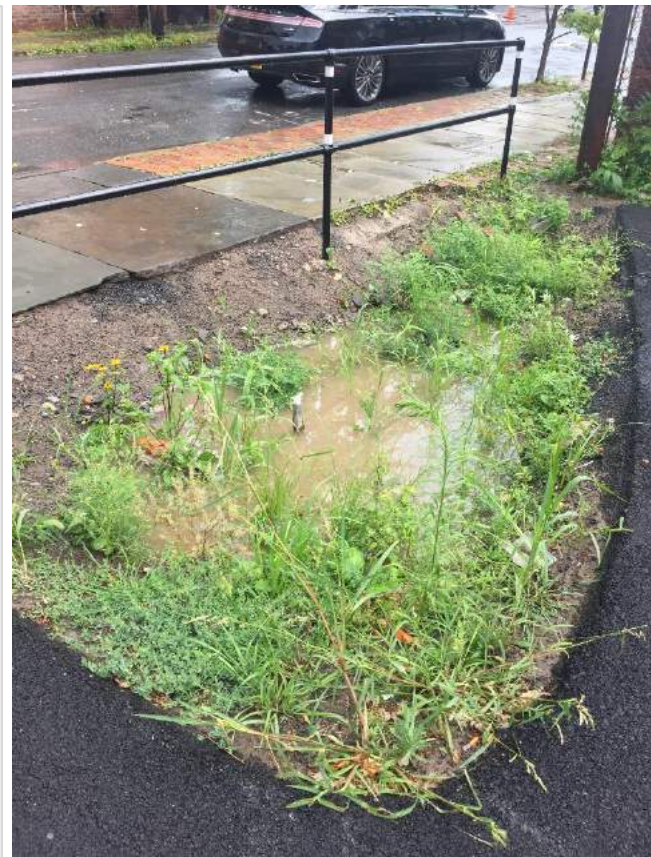
Bioretention South 3 - August 4, 2017

Bioretention Areas without Underdrain

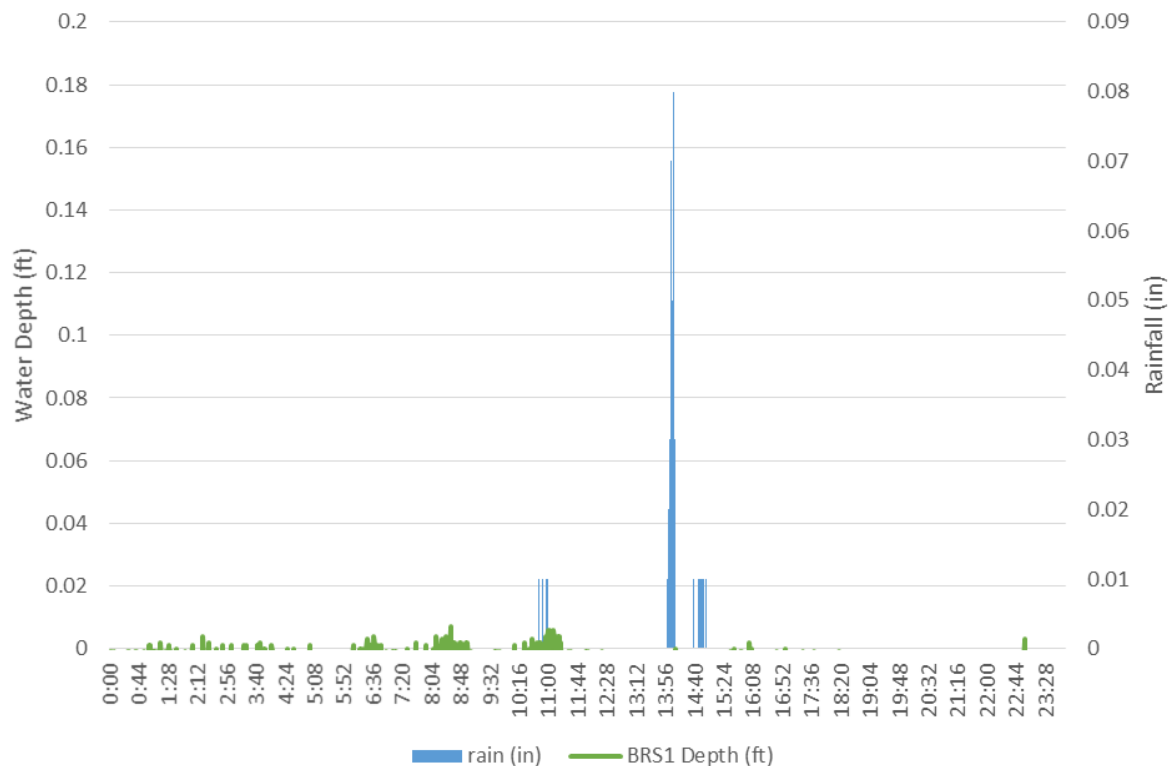
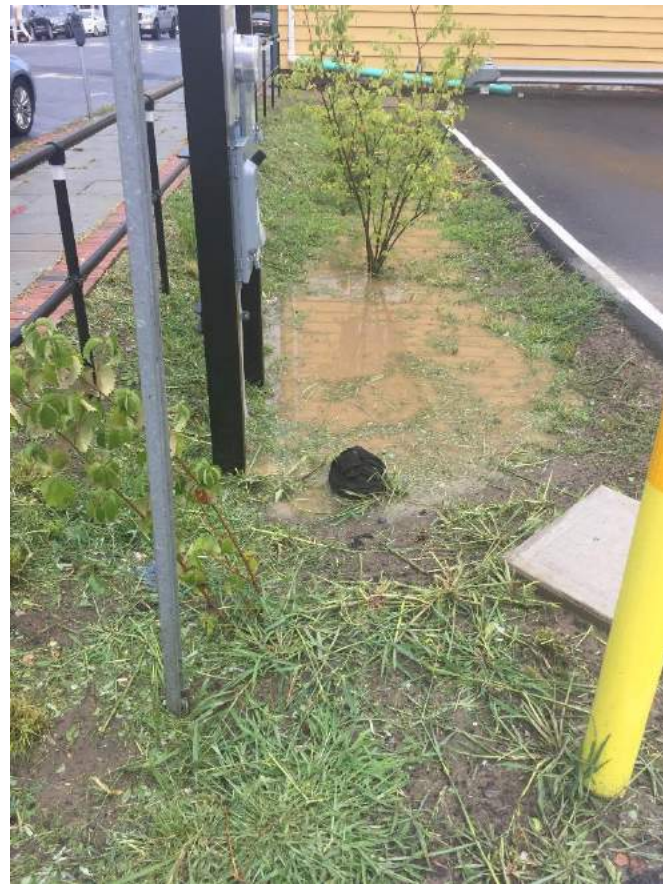
Bioretention South 1 - August 4, 2017

Bioretention Areas with Underdrain

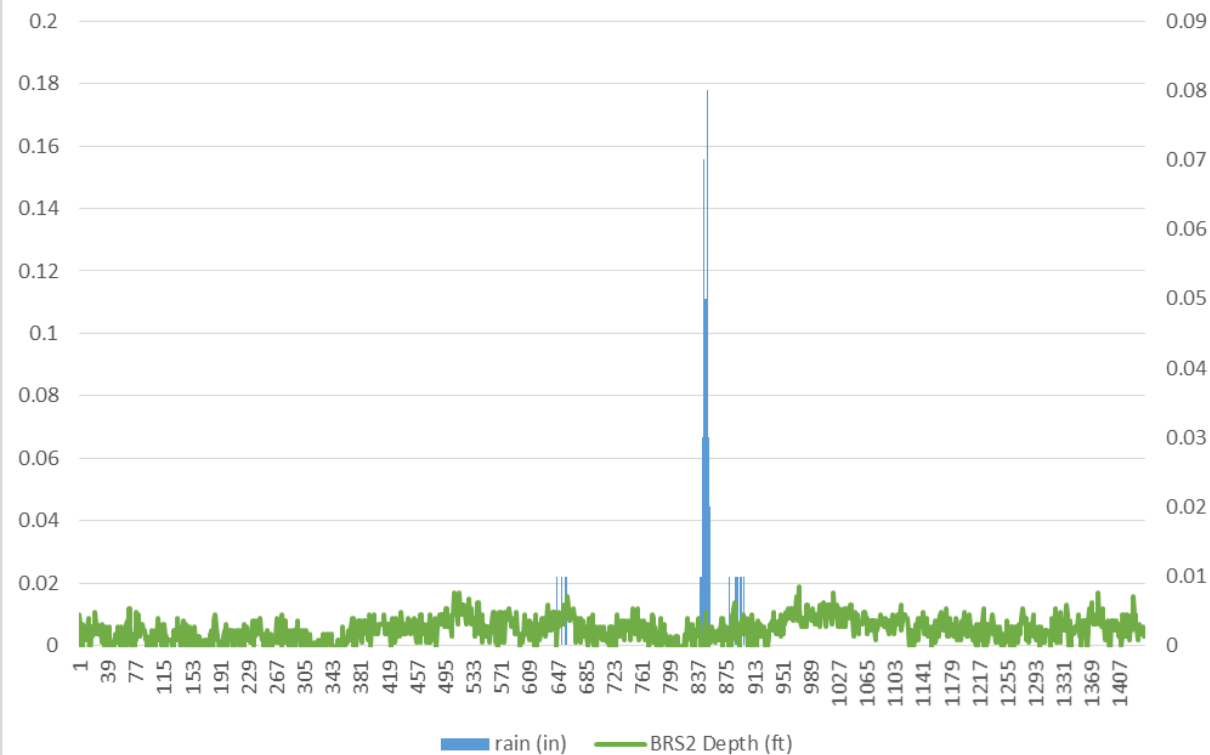
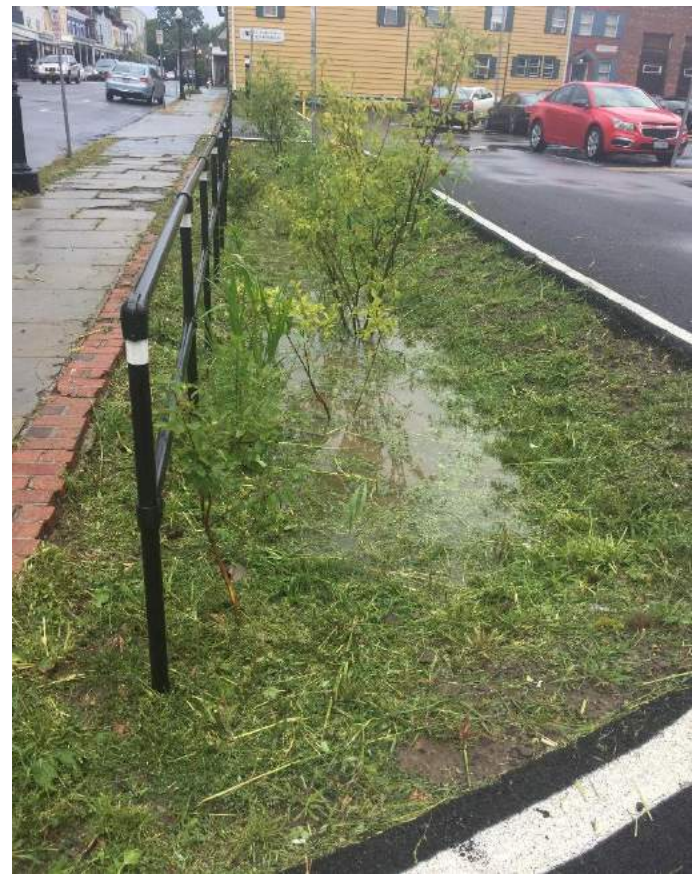
Bioretention South 2 - August 4, 2017

Bioretention Areas with Underdrain

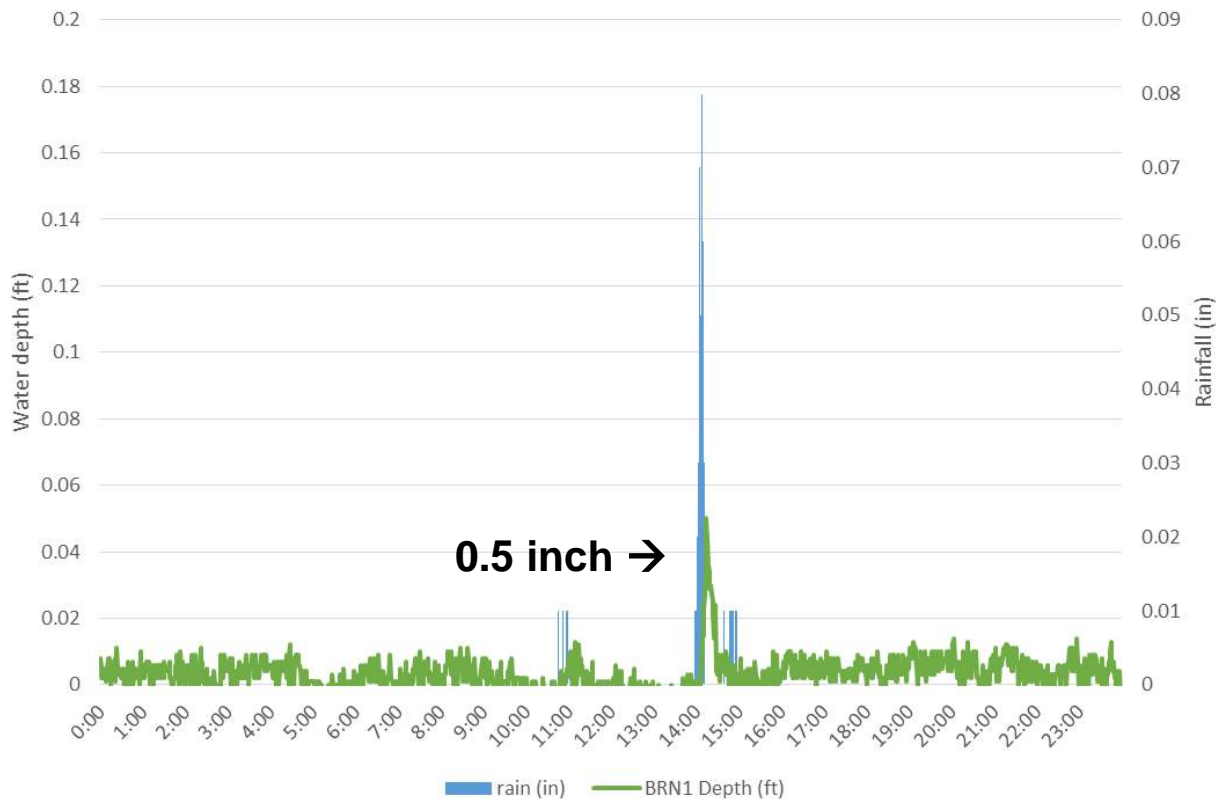
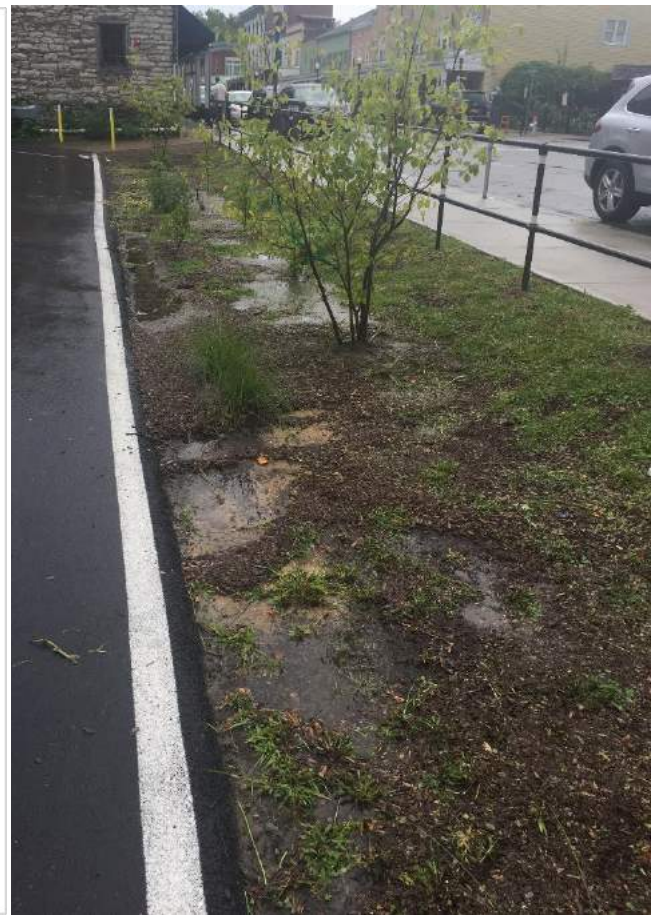
Bioretention Area North 1 - August 4, 2017

Bioretention Areas with Underdrain

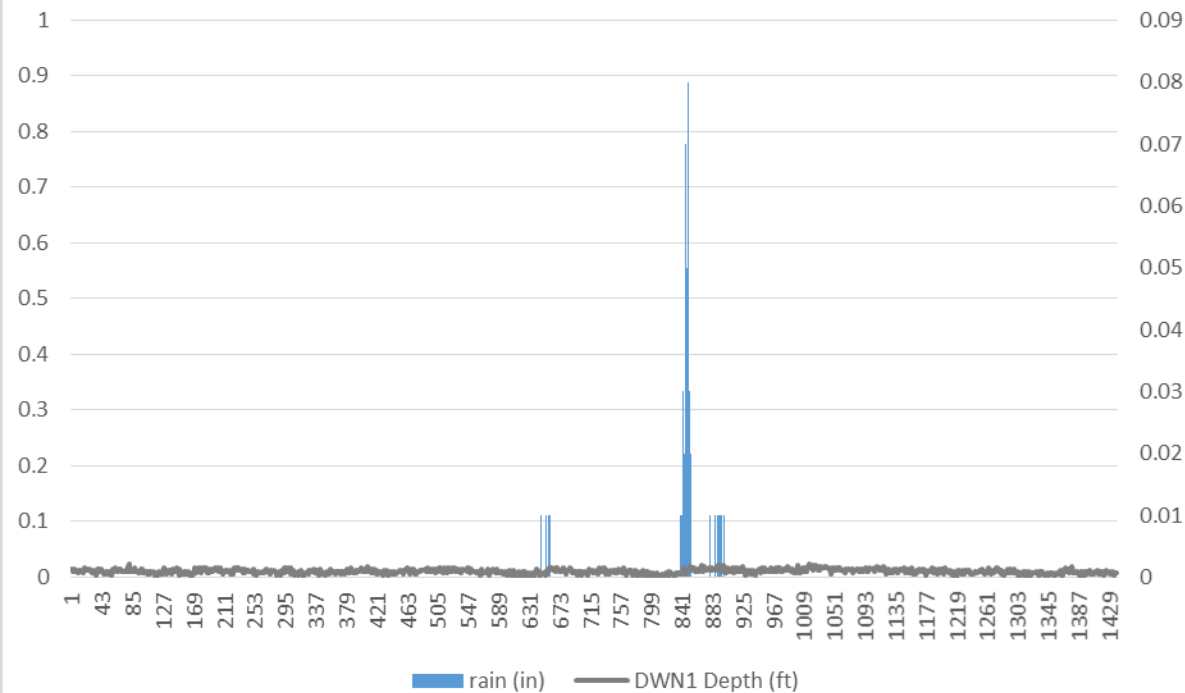
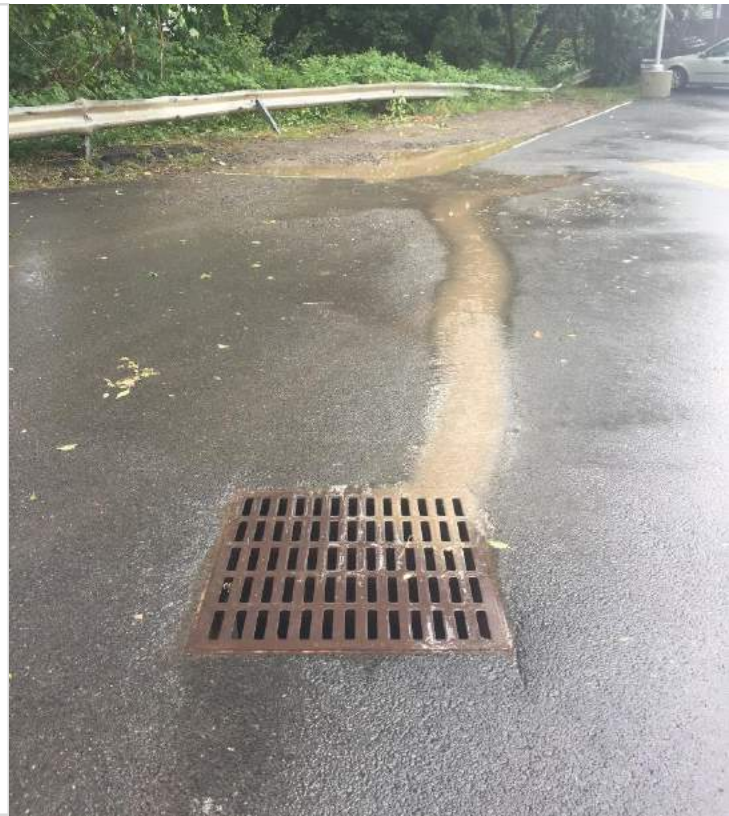
Dry Well North 1 - August 4, 2017

Dry Well

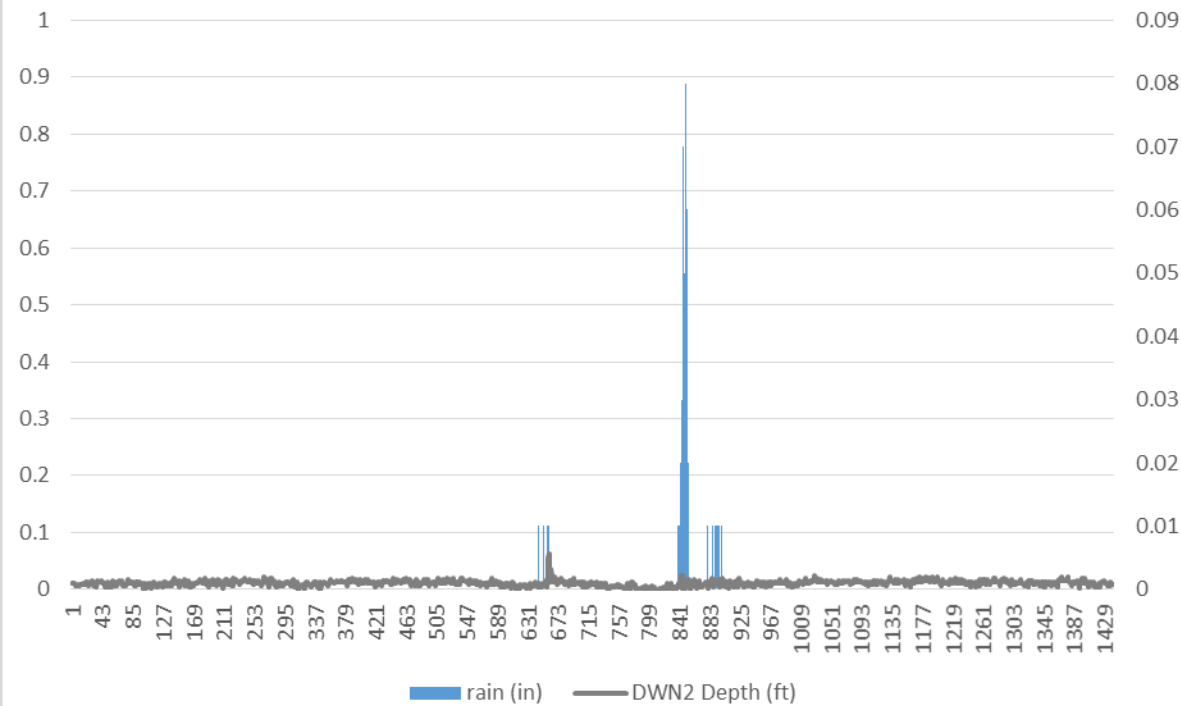
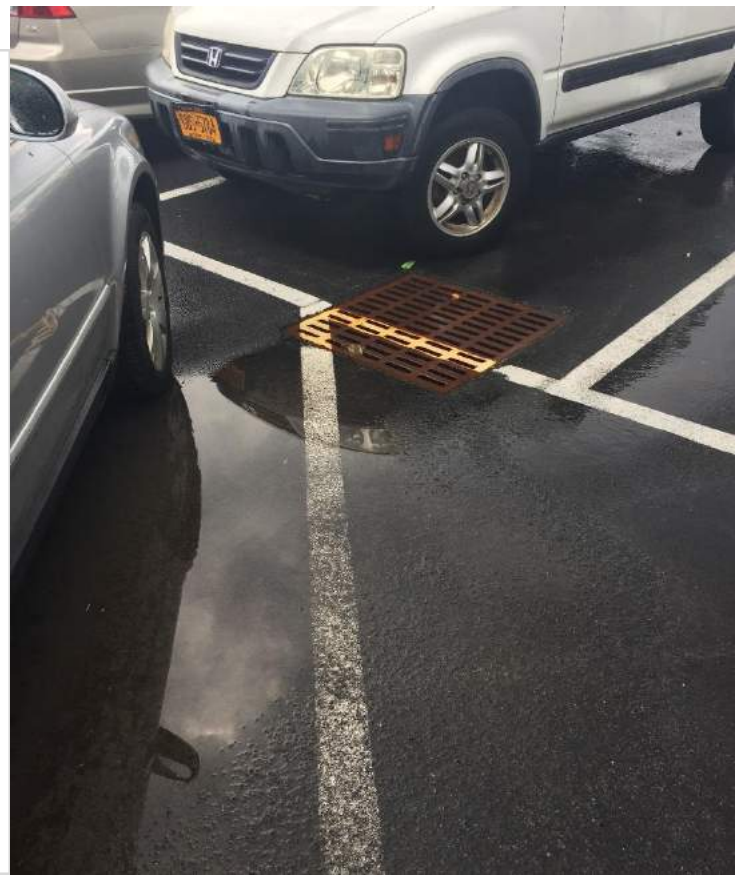
Dry Well North 2 - August 4, 2017

Dry Well

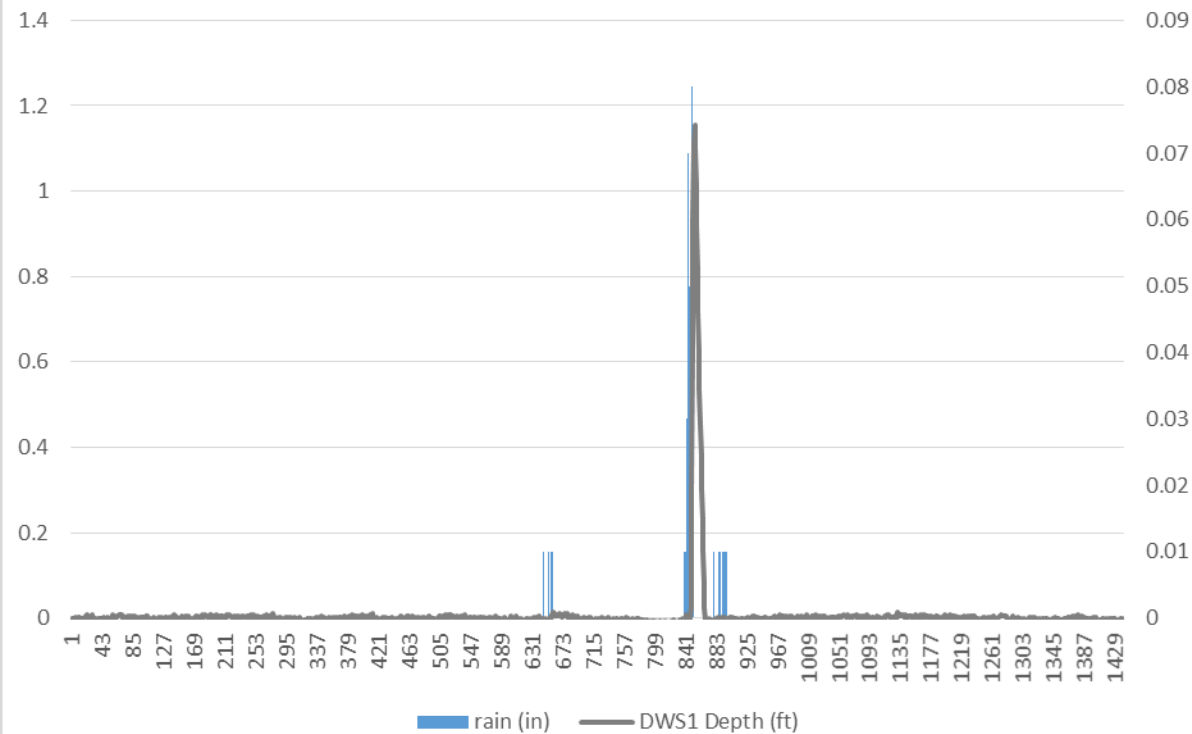
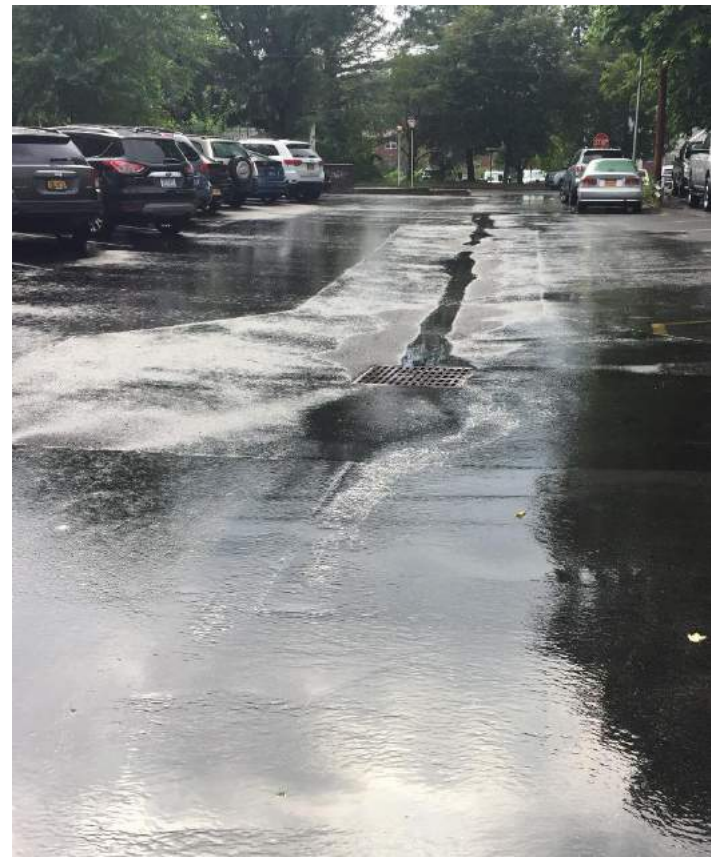
Dry Well South 1 - August 4, 2017

Dry Well

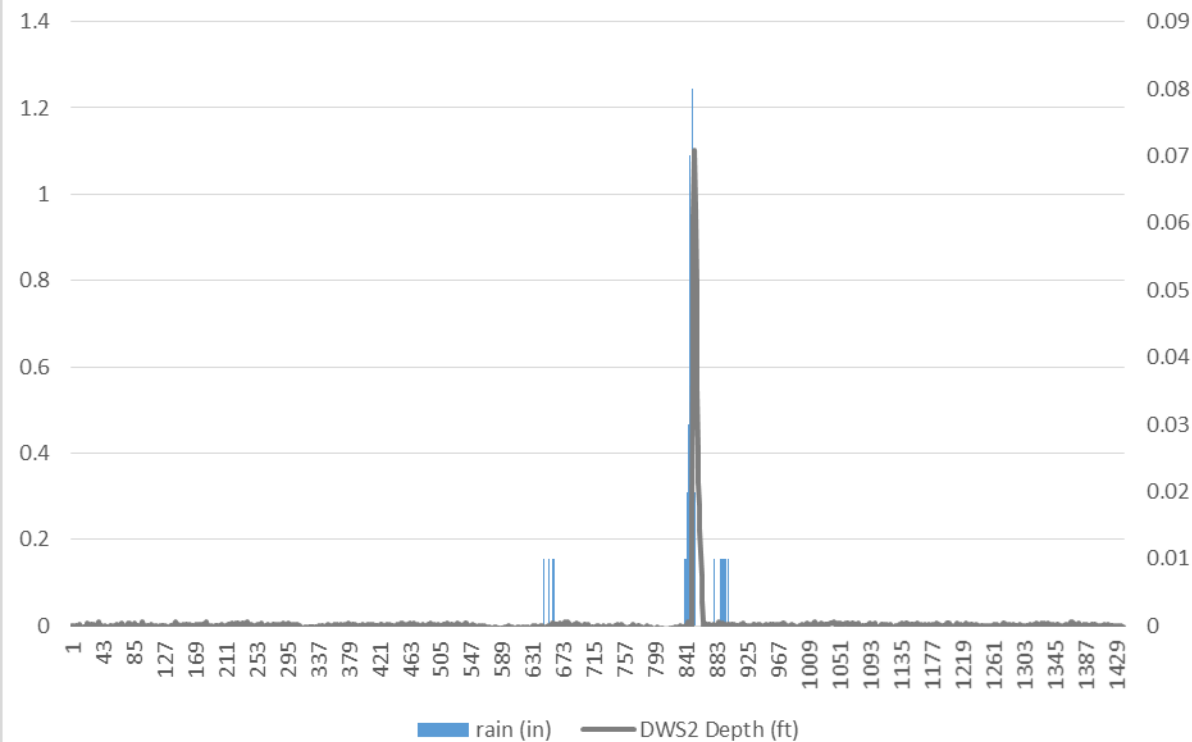
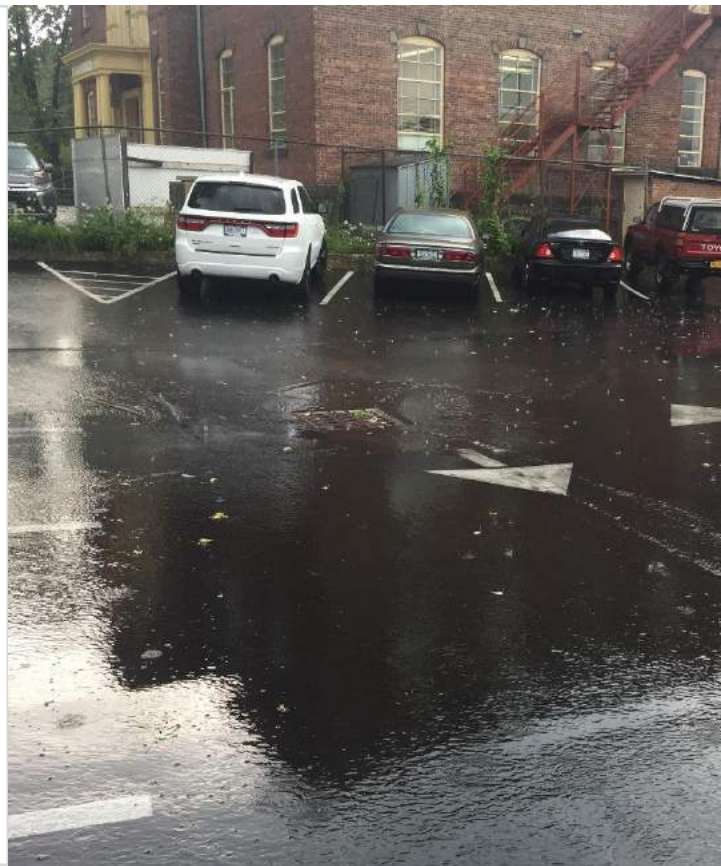
Dry Well South 2 - August 4, 2017

Dry Well
