Assessing Green Infrastructure: Kingston Uptown Parking Lots

Emily Vail

Hudson River Estuary Program,
NYS Department of Environmental Conservation
NYS Water Resources Institute at Cornell University

October 18, 2017

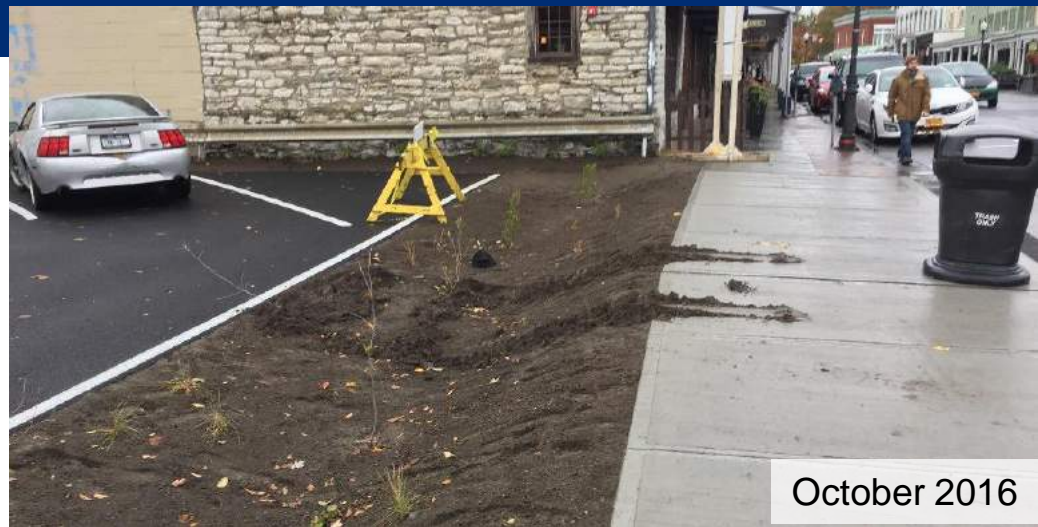
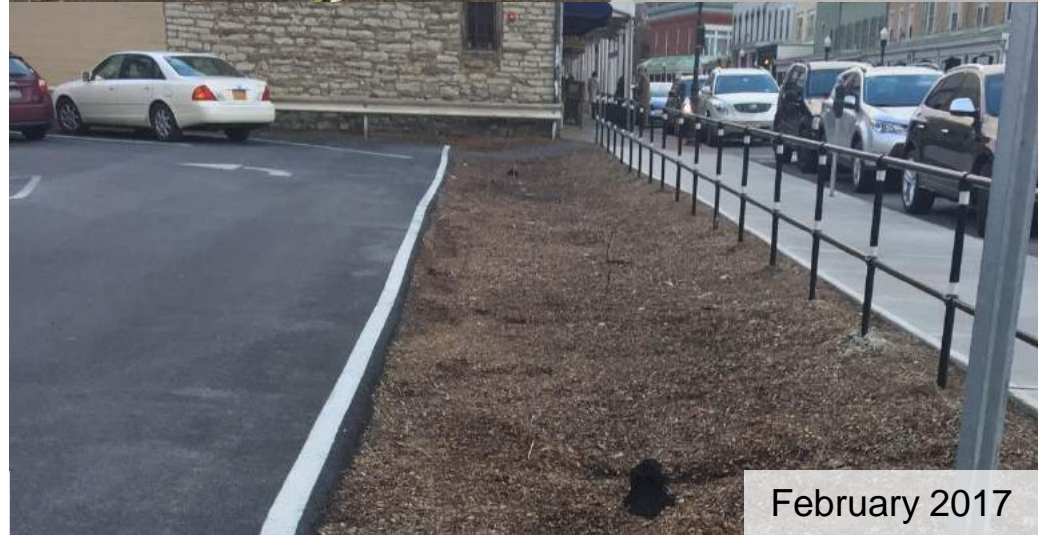
Bioretention Area North 1

- Cars kept driving through bioretention areas
- Installed fences with reflective tape along 4/5 bioretention areas to prevent this

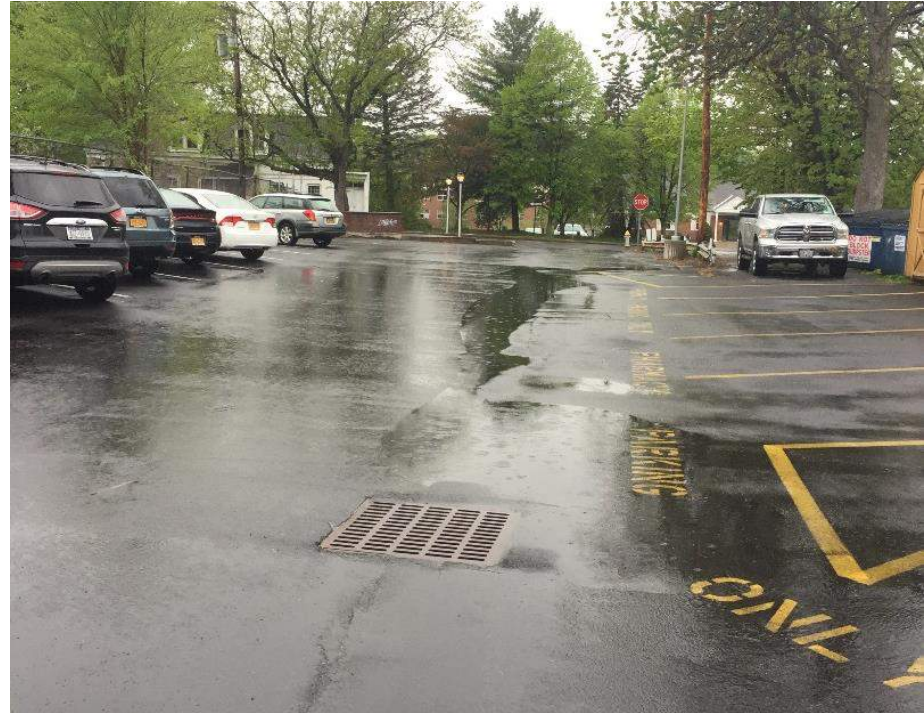
Dry Well South 1 – May 5

- Too steep (Dry Well South 2)
- Water bypassing dry well (Dry Well South 1)

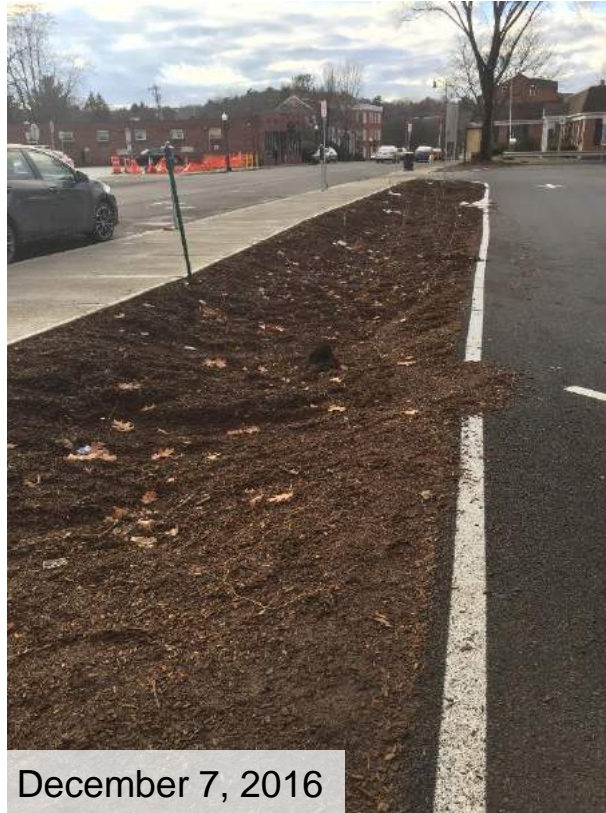
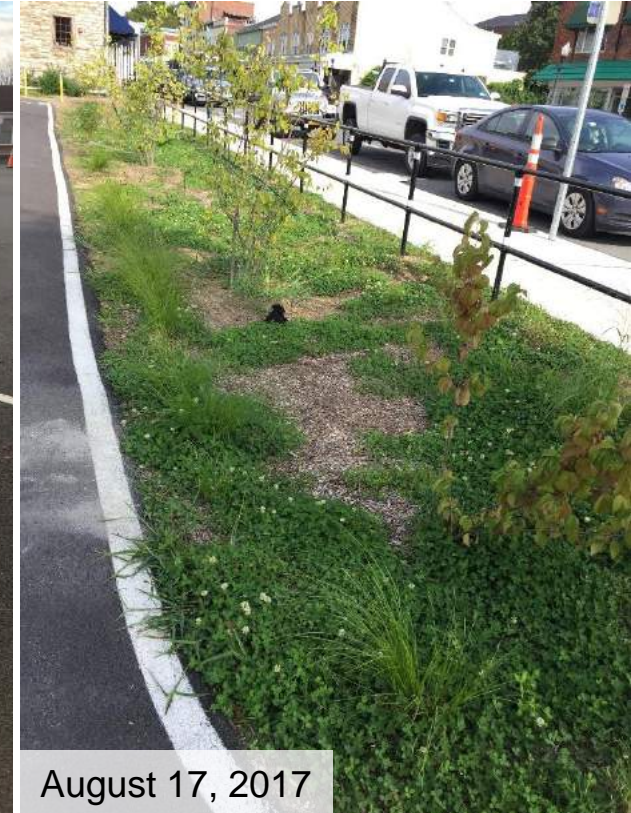
- Only one practice has mulch – weed growth, maintenance
- Snow removal, mowing has damaged some trees

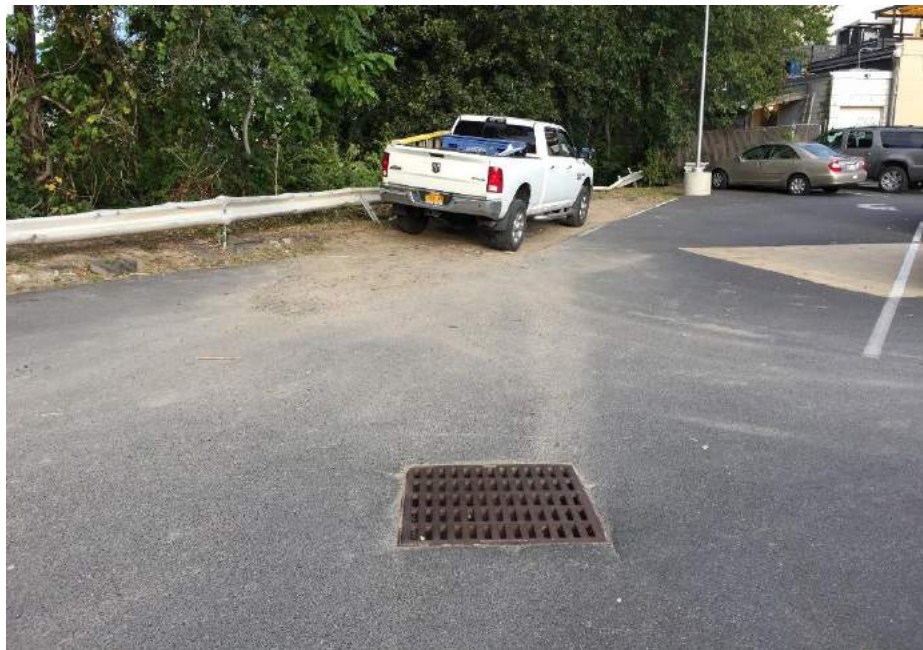
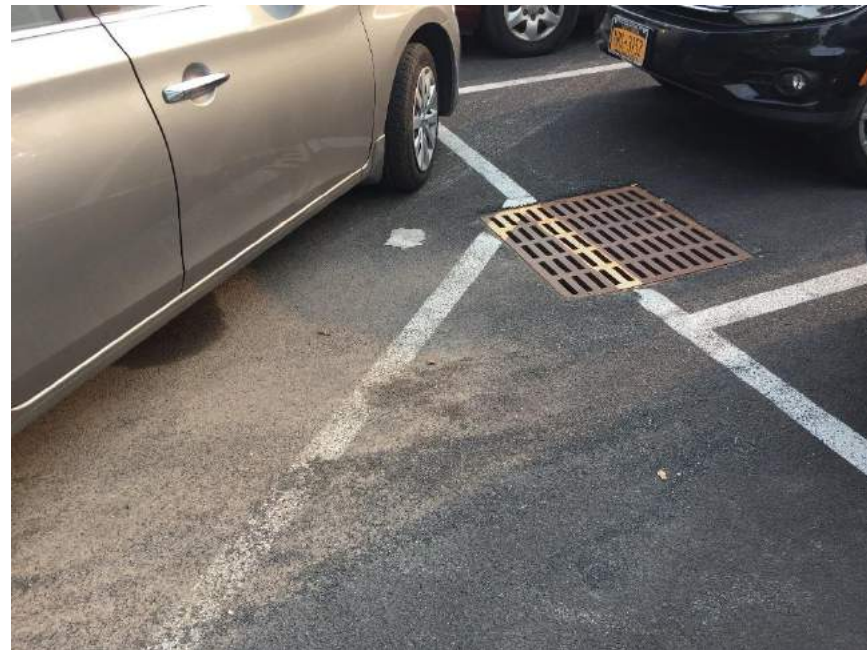
Potential for Clogging
